**Site Visit Observations of Team consisting for Assi River Rejuvenation by Pond  
Conservation in the Catchment Area of Assi River**

**Date of Visits:** 23/08/22-26/08/22.

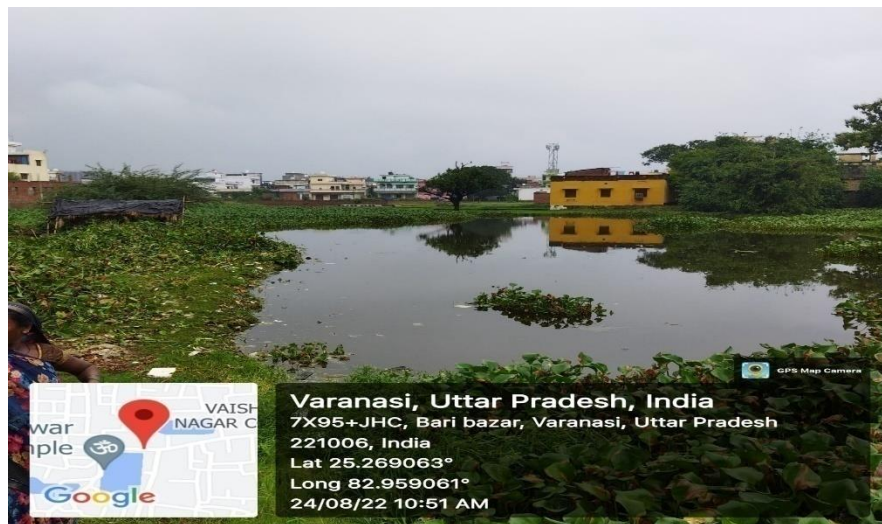
### Origin Pond of Assi River:

1. Pond is heavily encroached; no boundary is marked and used for fish farming allotted by local Pradhan.
2. Due to absence of Sewage network all household waste water & sewerage directly or indirectly enters into the pond.
3. Solid waste dumping was observed.

- i. The encroachment removal at Assi/ Ponds/ Kunds at Varanasi is required. Identification and marking of pond boundary with old revenue records needs to be done to restrict future encroachment.
- ii. No possibility to remove huge encroachment along Assi river channel - nearly 1000 homes, therefore the restoration plan should primarily focus towards increasing the

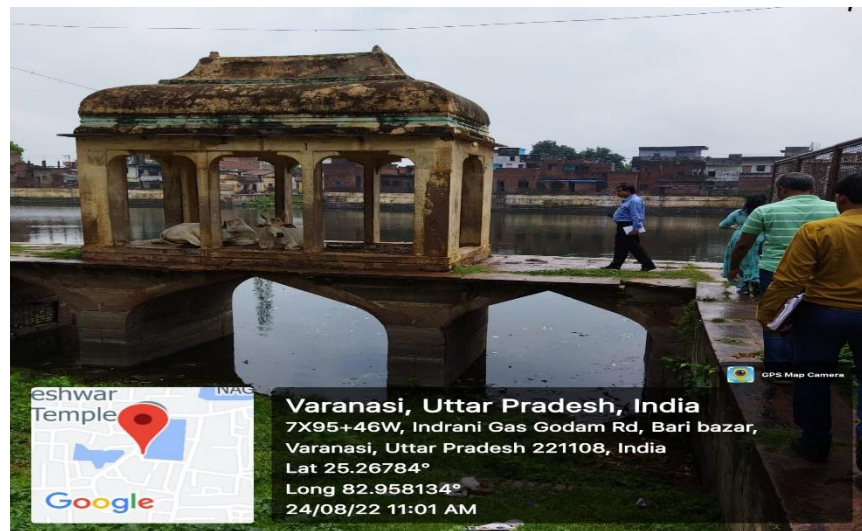
### Pond on KardmeshwarMahadev Temple:

1. Pond is situated in the premises of KardmeshwarMahadev Temple.
2. bathing & laundry activities found during the site visit
3. No outlet found, however the inlet of the pond seems to be connected to the pond of origin through seepage.

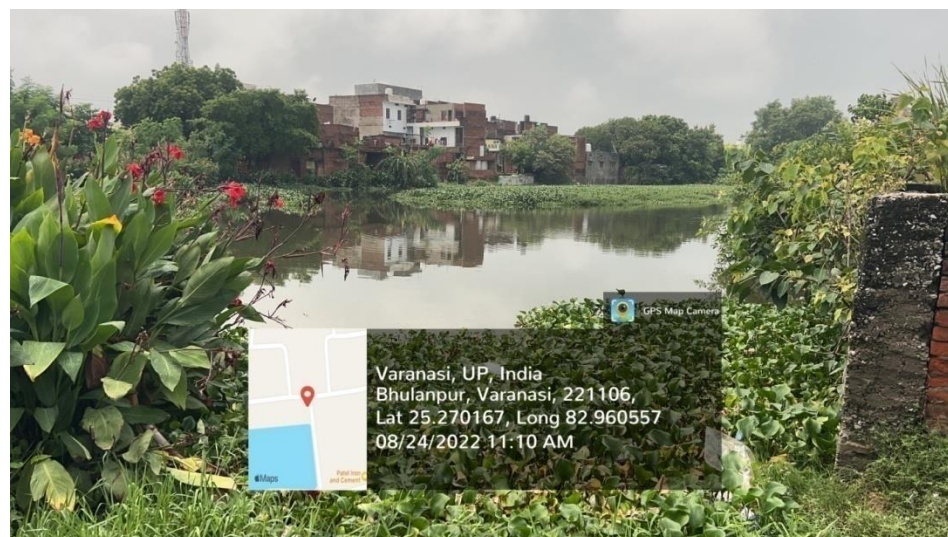
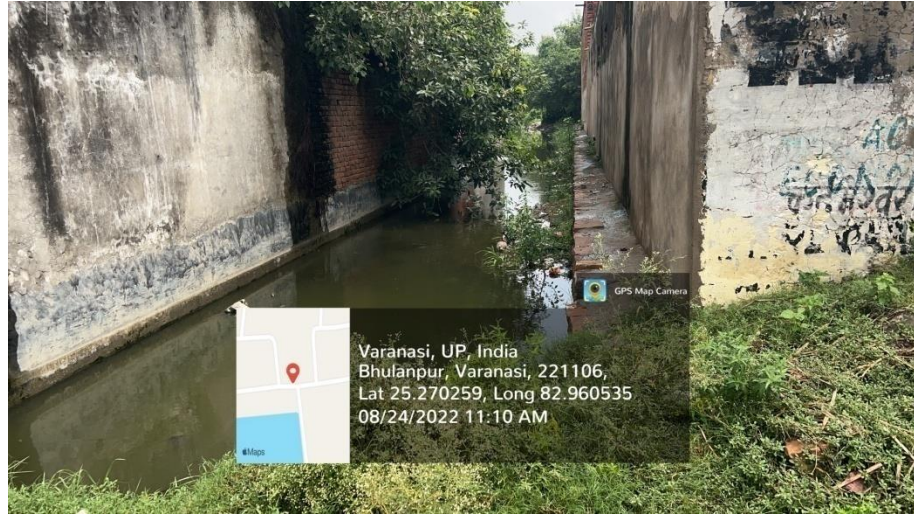
### KandwaPokhri:

1. A large population surrounds the Pond & also encroached upon, as it has no fixed boundary.
2. Due to absence of Sewerage network all household waste water & sewerage enters directly or indirectly into the pond
3. Assi channel/ nalla/ drain starts from here & contribute waste water & sewerage in the Ganga river as shown in figure below.

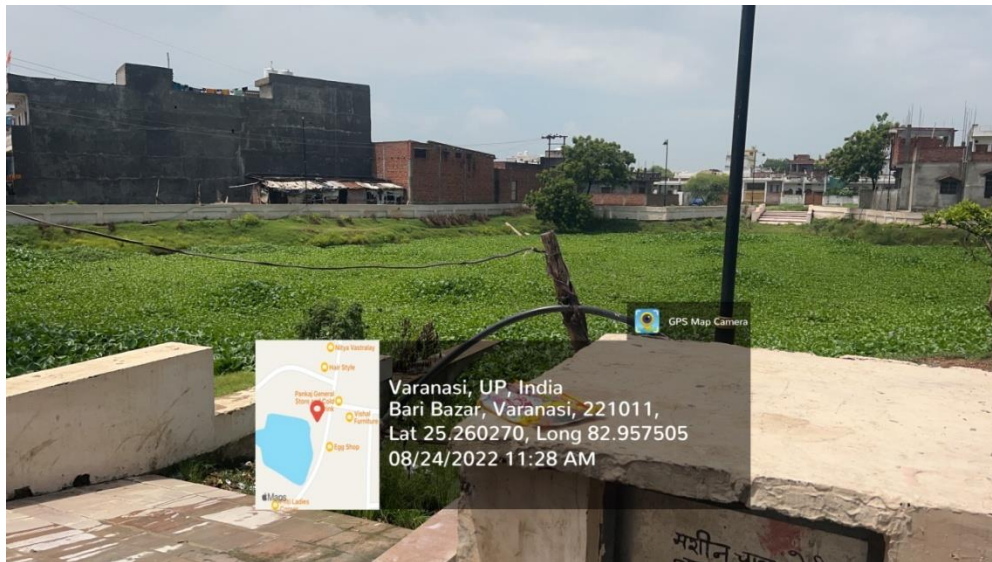
### RewaTalab:

Rewatalab is already rejuvenated by VDA under phase-1 funded by NMCG. But presently pond is heavily weeded as shown in picture below.

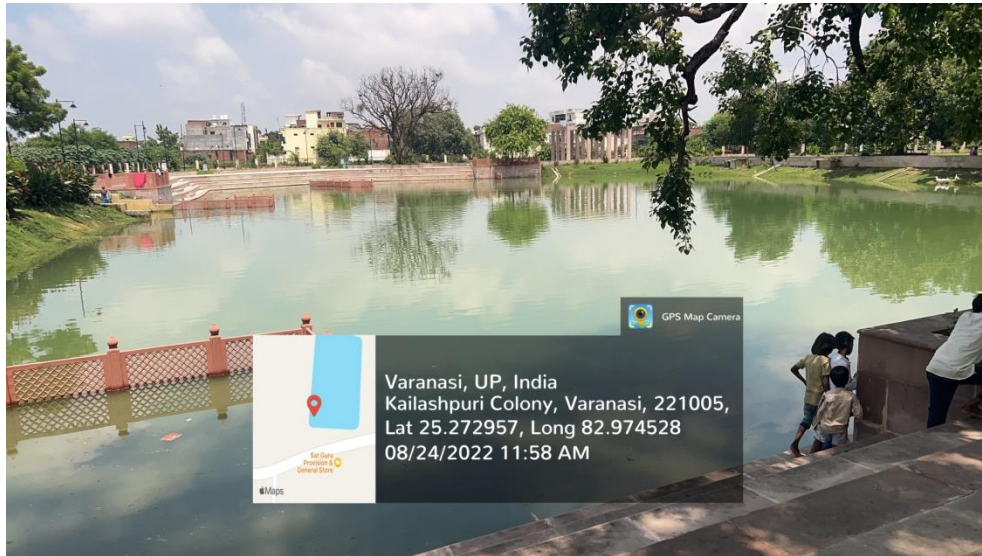
### KarondiPanchkoshi Road Talab:

Panchkoshitalab is already rejuvenated by VDA under phase-1 funded by NMCG. However algal bloom was found within the water body.

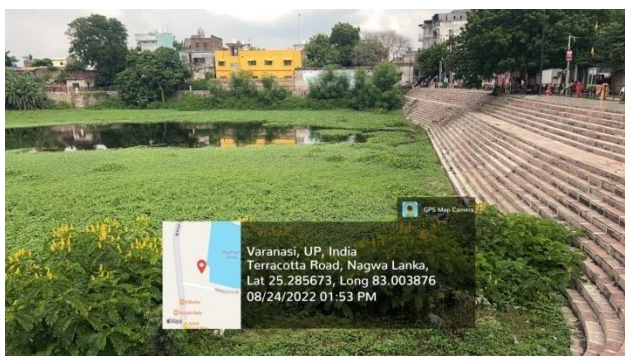
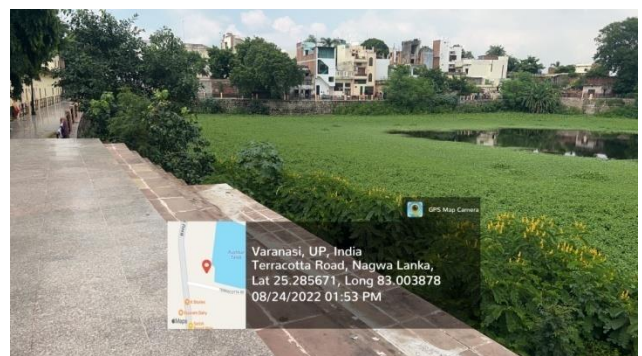
### PushkarTalab:

PushkarTalab is already rejuvenated by VDA funded by NMCG. According to local people pond water depth is around 40 to 45 feet and having good aqua culture like big fishes, turtles etc. At the time of rejuvenation, ponds inlet and outlet have blocked due to construction activities like bank steps & ghat development, due to this water is coming in the pond through seepage under the stairs from nearby Assi River/ Ganga River.

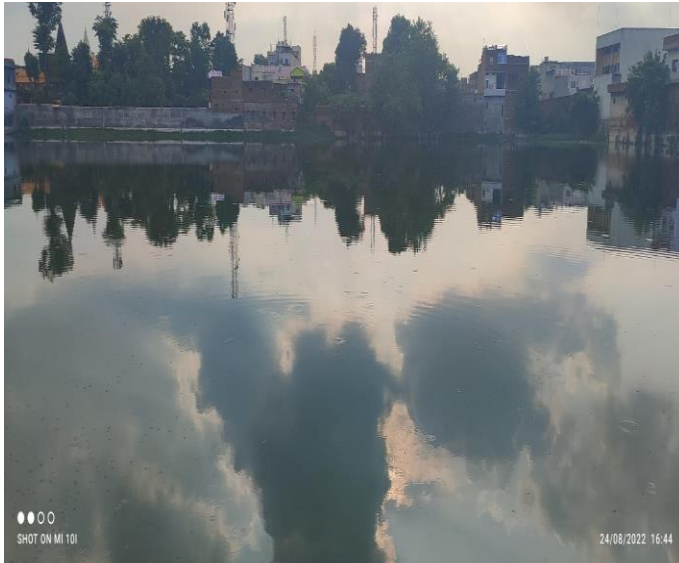
**Lahartara Pond**

No Eicchornia was found. Some work of Natural Treament was taken up by VDA however later it was stopped due to dispute between ASI and VDA. The treatment showed some sludge digestion has taken place as the level of water body has reduced. The pond was clean as compared to adjacent one.

- iv. Some area (approximately 10~20 feet) should be secured around embankment of the Waterbody.
- v. Physical dredging shouldn't be done since it disturbs the limnology, rather eco-dredging, like the way it has happened in Lahartara Project (wherein the sludge has been consumed, while keeping the Water levels intact and reclaiming the space by about 5 feet) is the way to go forward on restoration projects.

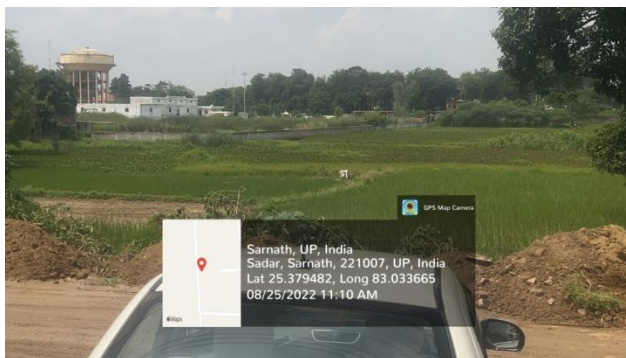
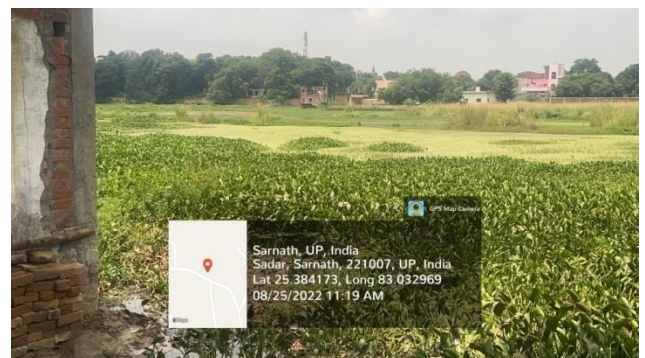
### NarokharTalab near WTP, Sarnath, Varanasi

NarokharTalab is situated back side of WTP near Sarnath Railway Station and expanded in the area of 85 acres. Pond is completely filled with Eicchornia&water chest nuts are also grown by locals.

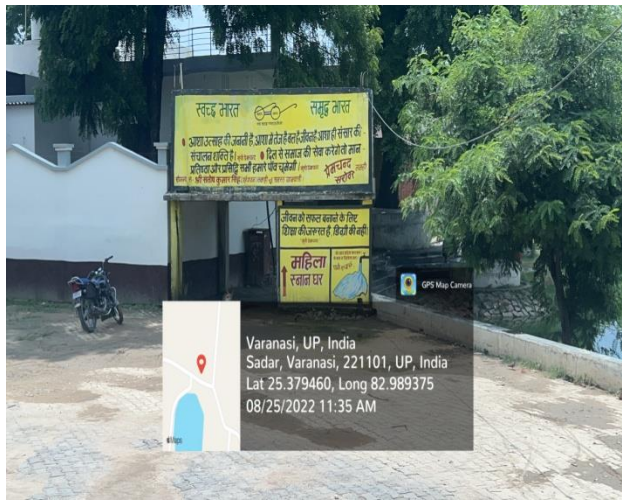
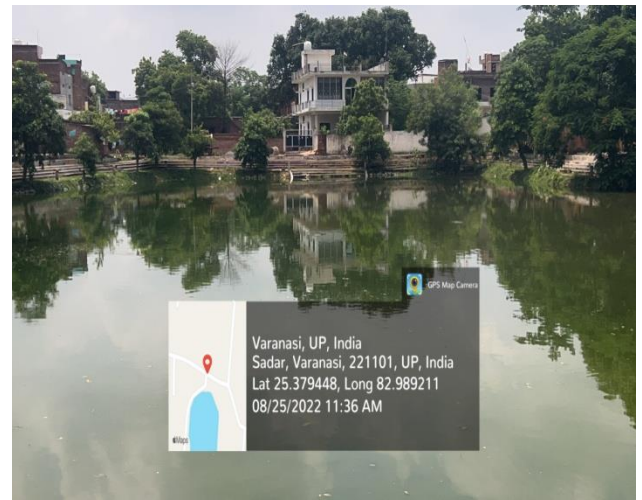
**Prem Chand Sarovar:** Algal growth was present.

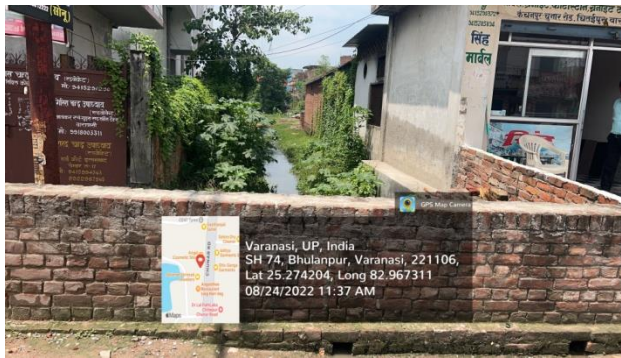
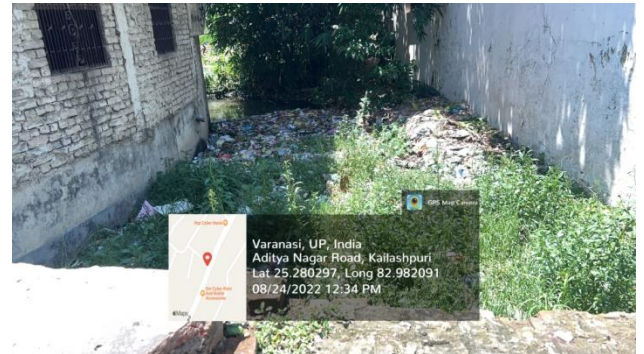
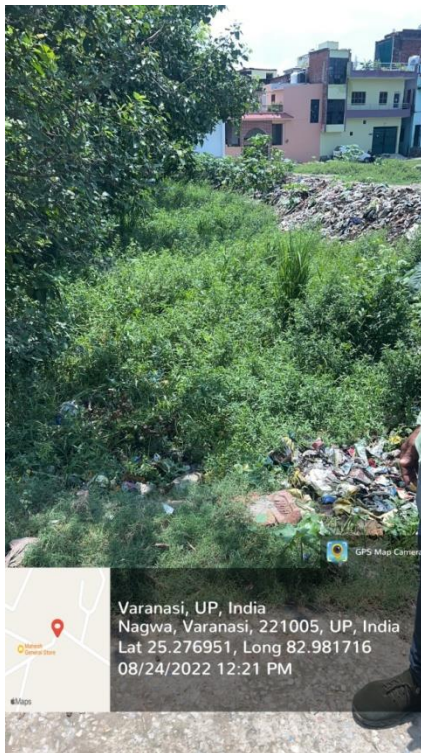
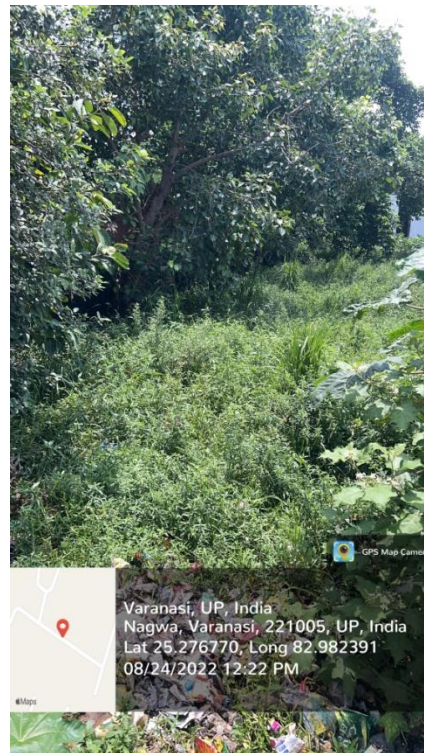
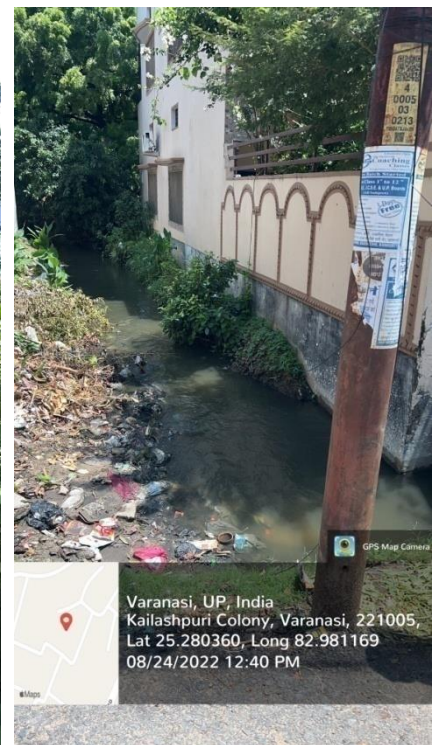
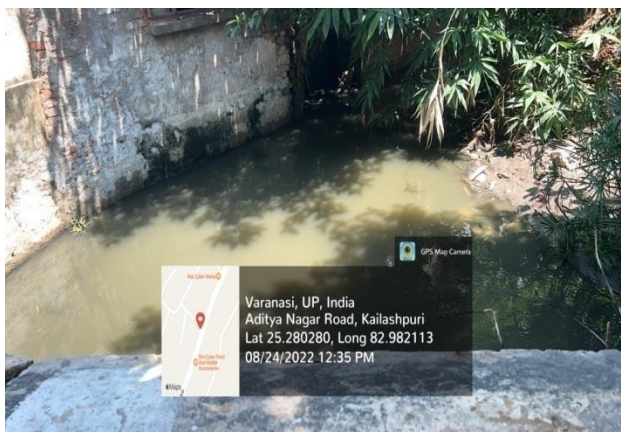
## Assi River/ Nala Encroachment Areas:

2. Solid waste dumping into Assi River/ Pond/ Kunds directly.
3. Heavy encroachment at River Embankments/ waterbodies.
4. Unprecedented residential commercial growth due to VIP constituency.

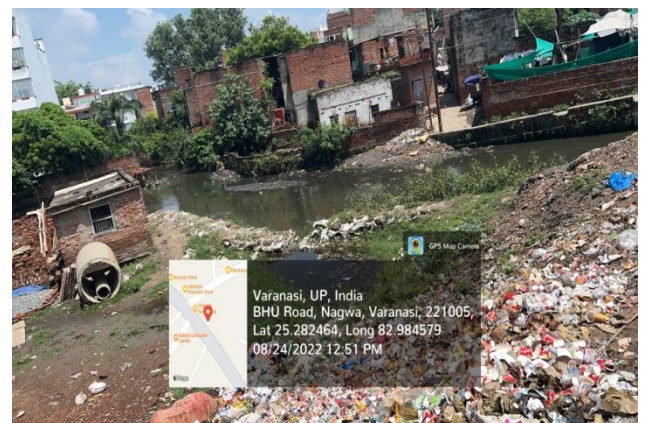
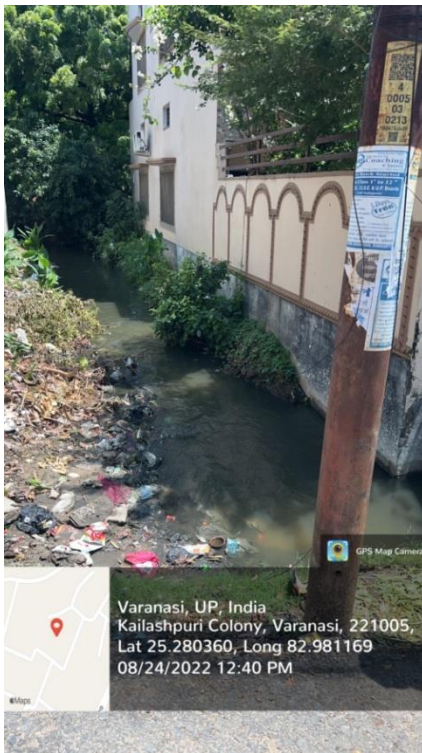
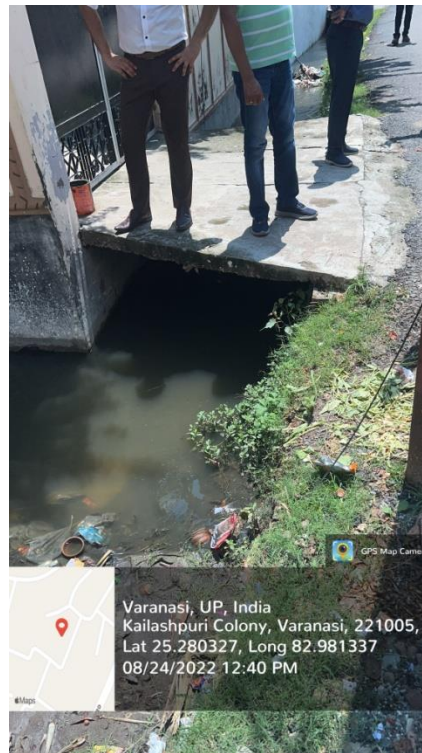
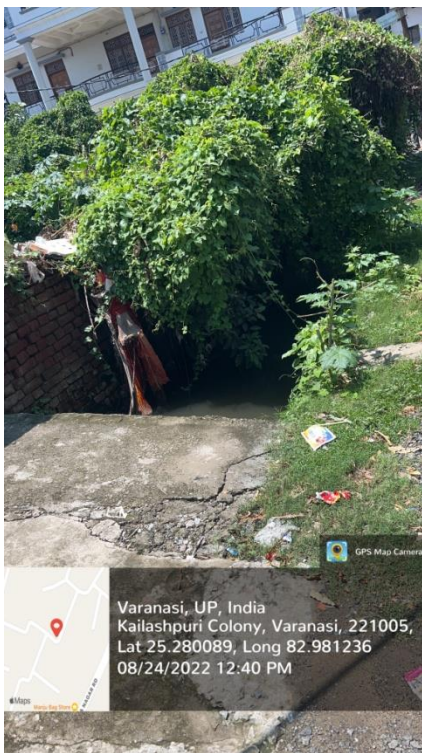
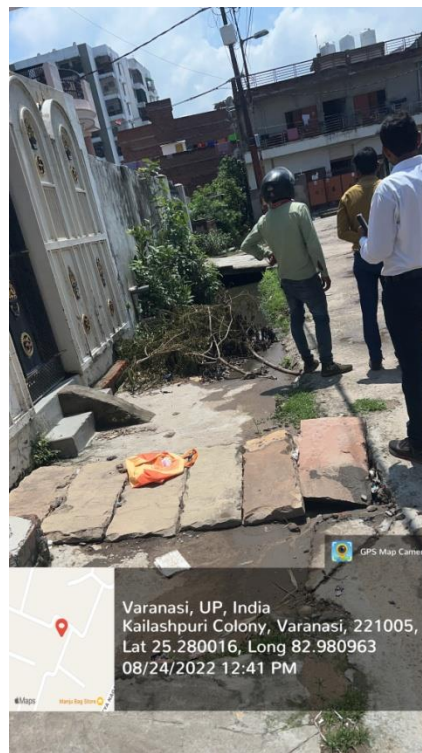
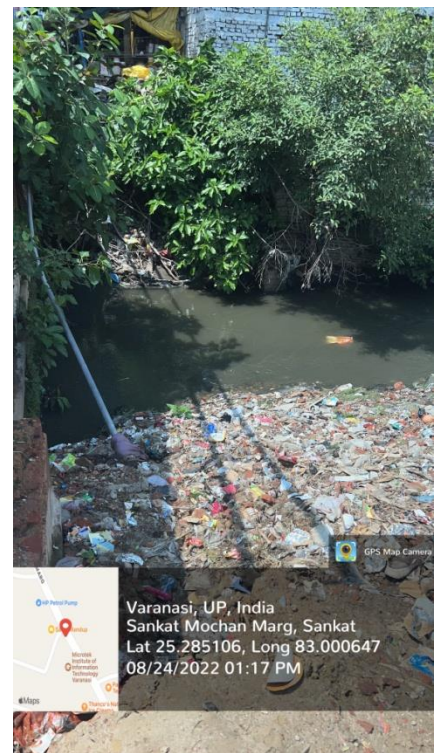
1. The entire 8 km stretch of Assi River/ Nala passes through the core heavily populated area of Varanasi. All the sewage/ wastewater from District 3 Varanasi finds its way into the water bodies/ ponds/ kunds and traverses through the Assi River/ Nala, thereby generating a mix of wastewater/ fresh water in water bodies/ storm water. This mixed water is tapped at Nagwa PS and treated at 50 MLD Ramana STP. The water which reaches the STP is diluted (less BOD Load) and quantity of water available for treatment is huge resulting in large STP capacity demand and huge O&M.

- i. District C is heavily populated and there is no scope for further expansion and development. It is saturated. Since interceptor sewer and trunk sewer is already in place, laying of **Branch Sewer Network is recommended**. Sewage from households can be arrested by branch sewer network & diverted to nearest STP. This will lead to collection of Sewage of higher BOD load (>200 mg/L) and less volume of sewage will be available for treatment resulting in lesser O&M costs.

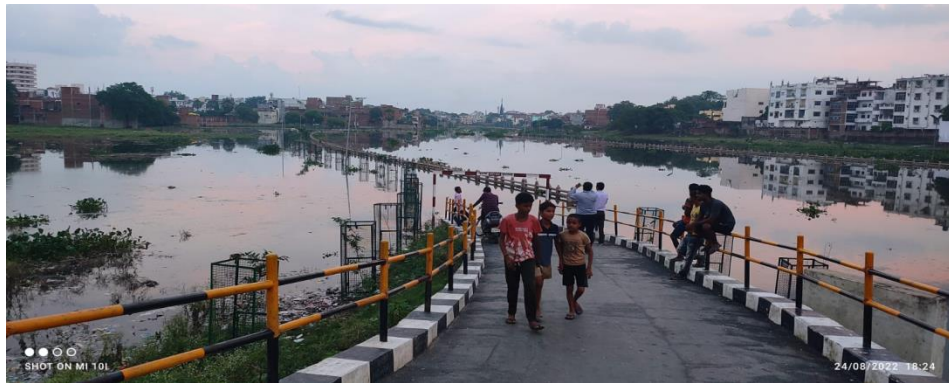
**Corridor submerged in Flood Water of River Varuna**

- iii. Could not approach the location where I&D works has been proposed (fig below) due to submergence in the Varuna river for flood water.
