**Site Visit Report**  
**for**  
**Pollution & encroachment in Gayatri**  
**Ganga River, District Hamirpur, Uttar**  
**Pradesh**

**Date of visit- 03.02.2026 to 05.02.2026**

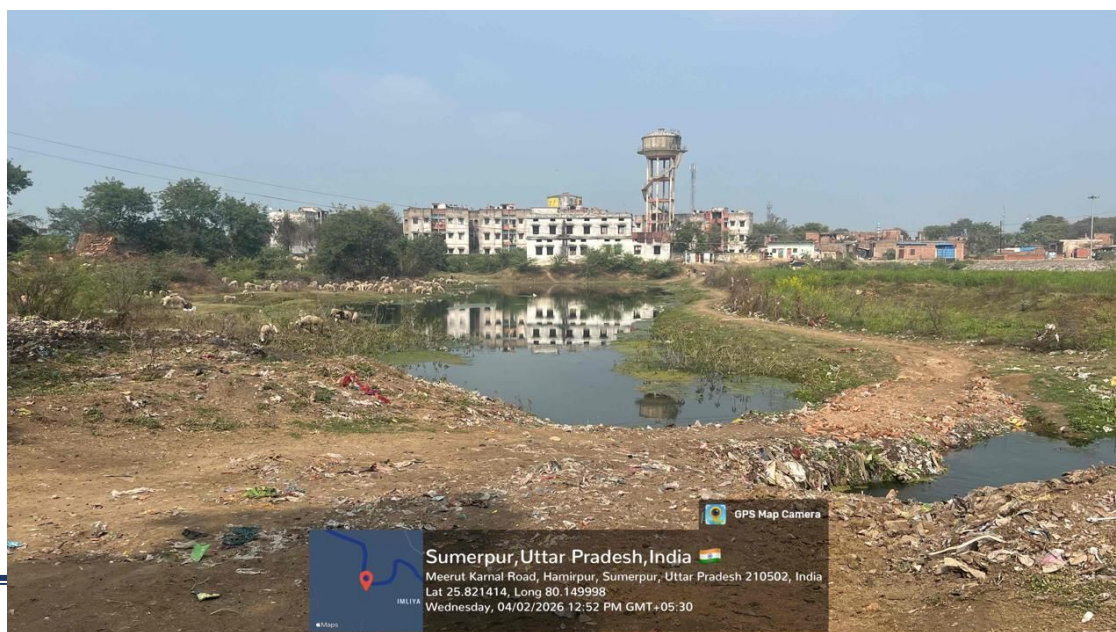
#### Site 1: Anusuya Ashram Northern Direction

GPS Coordinates: 25.821383°N, 80.149973°E

Nala Width: 22 meters

Area Encroached: 0.00 sq.m (Temporary)

Type: Temporary cultivation

Action Status: Demarcation completed

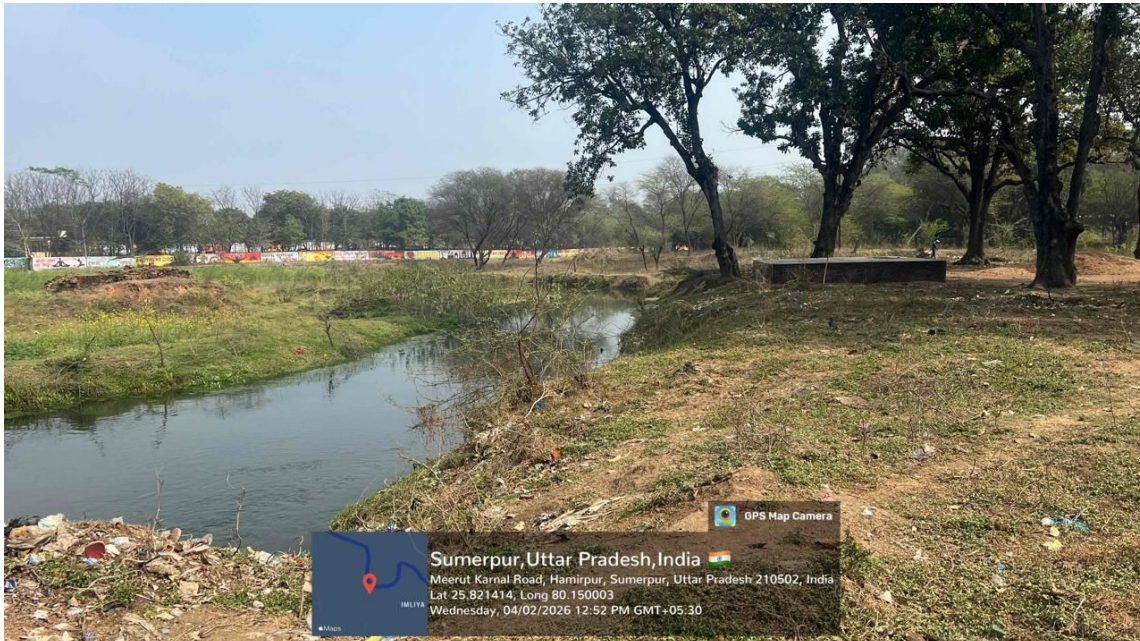
**Site 2: Behind Moksha Dham, Ward 03**

GPS Coordinates: 25.821452°N, 80.150020°E

Nala Width: 22 meters

Area Encroached: 0.00 sq.m (Temporary)

Type: Temporary structures

Action Status: Demarcation completed

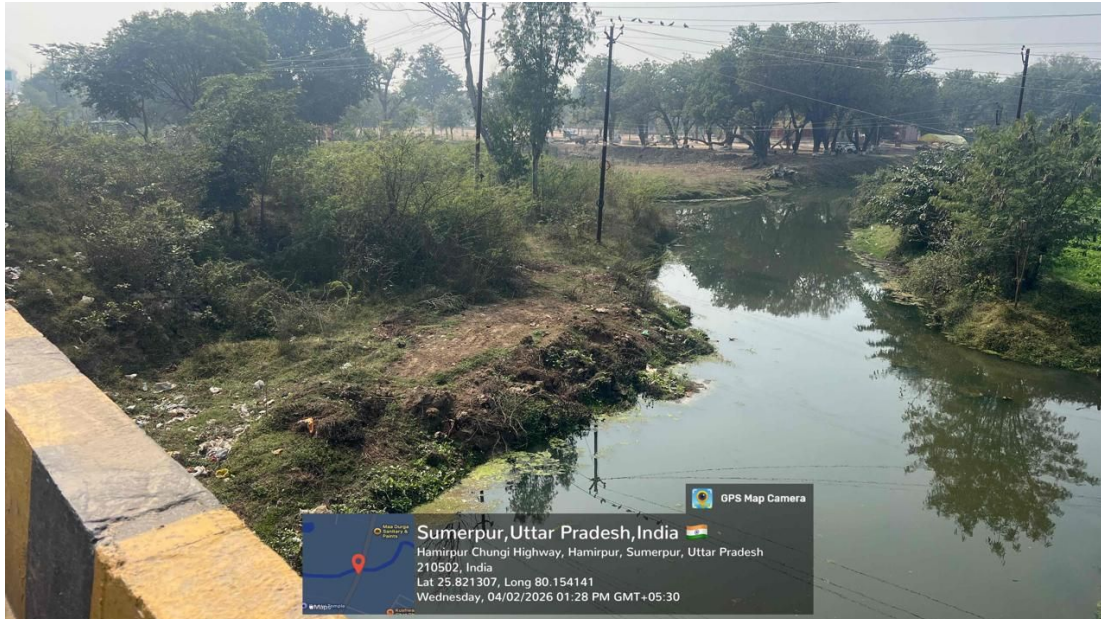
**Site 3: West Side NH-34 Bridge**

GPS Coordinates: 25.821285°N, 80.154148°E

Nala Width: 26 meters

Area Encroached: 0.00 sq.m (Temporary)

Type: Temporary

Action Status: Demarcation completed

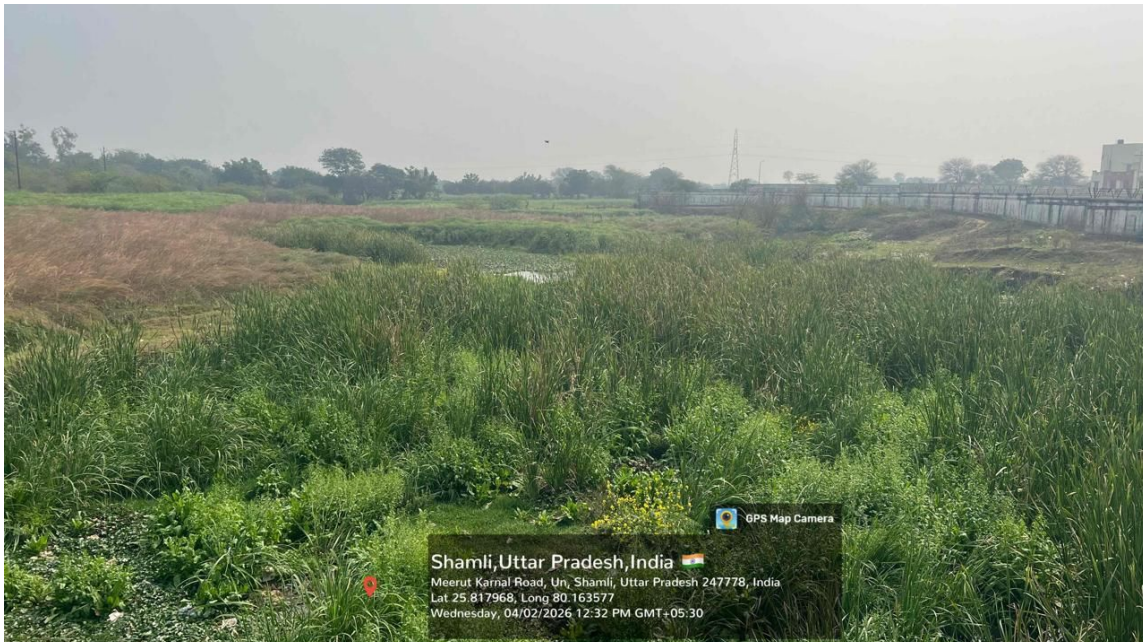
**Site 8: Railway Line Bridge towards West, Ward 09-04**

GPS Coordinates: 25.821329°N, 80.154151°E

Nala Width: 0.9-24 meters (Eastern section); 20-32 meters (Western section)

Area Encroached: 0.00 sq.m

Type: Temporary

Action Status: Documented

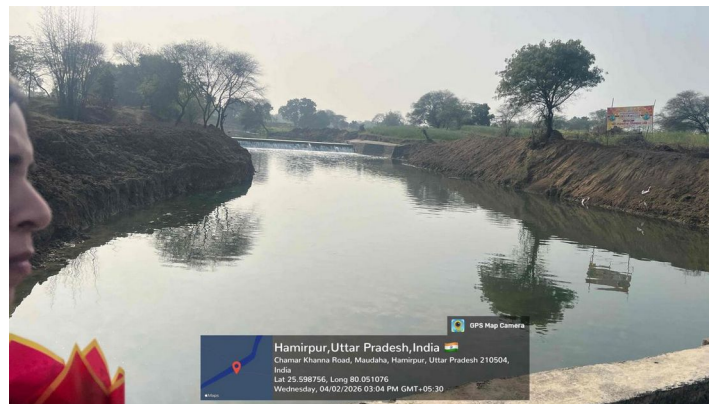
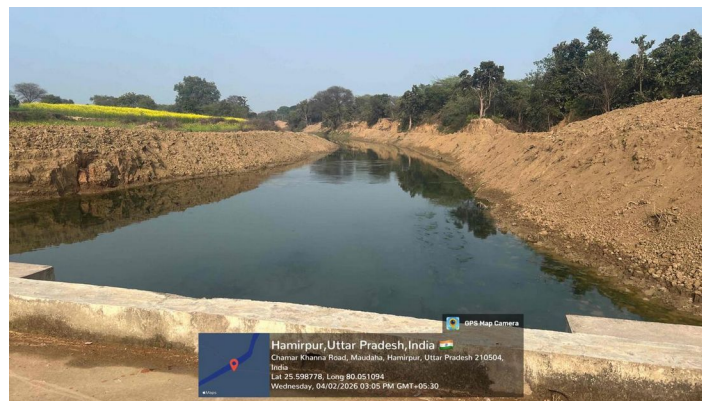
Site photographs at the time of visit:

now spreading 25–30 meters wide with a significant rise in water levels. The revival has reduced flood risks, reactivated groundwater sources, ensured year-round irrigation, improved agricultural productivity, and strengthened public trust in governance—emerging as a replicable model of sustainable river rejuvenation rooted in jan-bhagidari.
