## SITE VISIT REPORT: GUNIYA RIVER, GUNA, MADHYA PRADESH

## INTRODUCTION

The Small River Rejuvenation (SRR) Wing of the National Mission for Clean Ganga was established to extend the principles and learnings of river rejuvenation beyond the Ganga and its major tributaries to India's numerous small rivers, which are vital for local water security, biodiversity, livelihoods, ecological resilience, and ultimately play a vital role in determining the health of larger rivers. The wing supports States and Union Territories in planning and implementing integrated river rejuvenation initiatives through a basin-based approach that combines pollution abatement, ecological restoration, catchment conservation, environmental flow improvement, and community participation. It also promotes capacity building, knowledge dissemination, preparation of river rejuvenation plans, demonstration projects based on Nature-based Solutions (NbS), and convergence with various Central and State Government schemes to ensure sustainable management and restoration of small rivers across the country.

In this regard, a letter dated 23.05.2026 was received from the District Magistrate, Guna, forwarding a Detailed

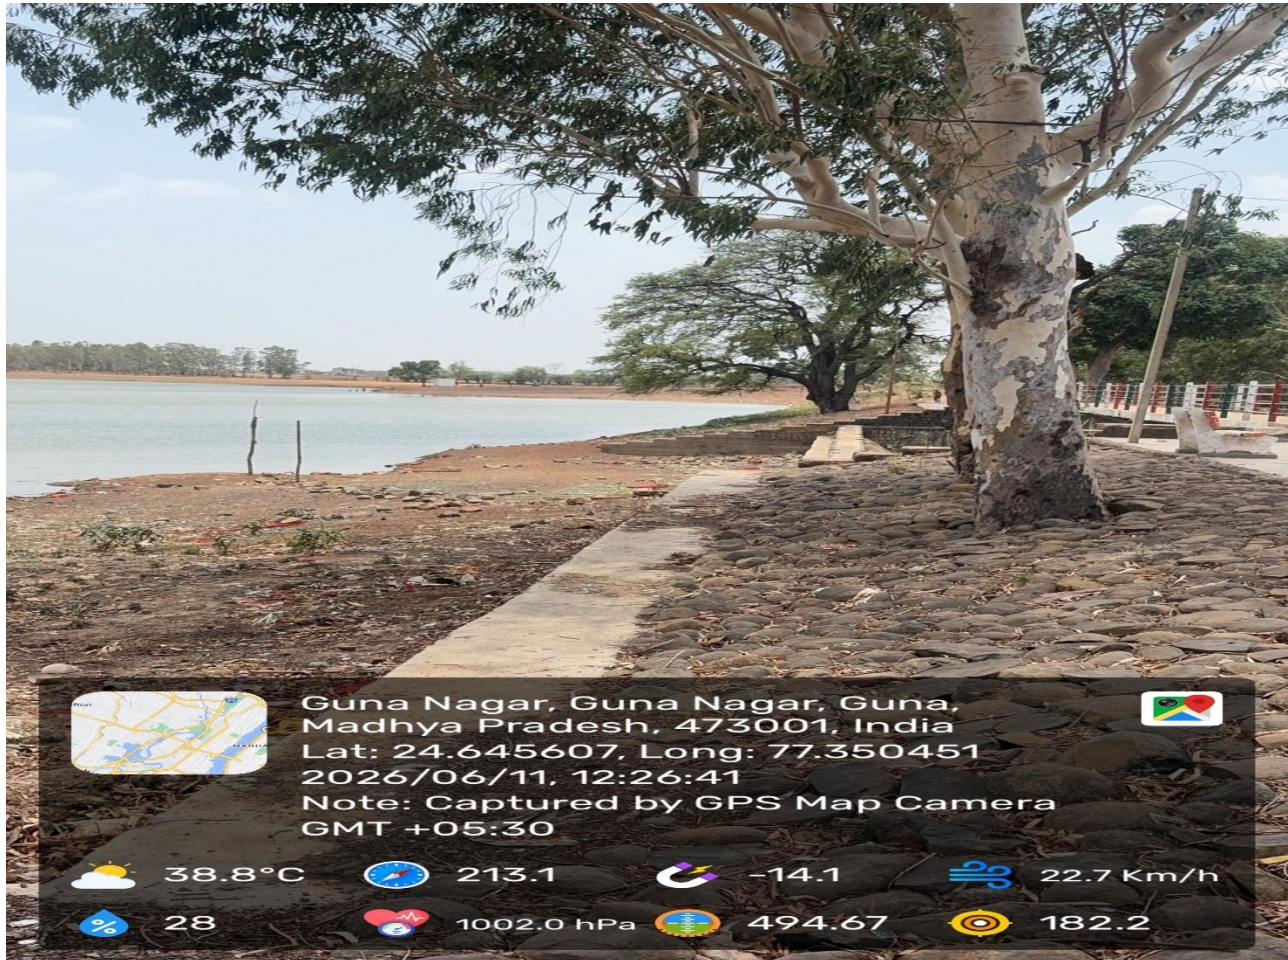
The site is considered the origin of the Guniya River, where the river emerges from Singhwasa Talab. The pond has already undergone Riverfront Development (RfD) works undertaken and maintained by the Nagar Palika, Guna. The existing infrastructure is generally in satisfactory condition; however, with periodic maintenance, improved landscaping, enhanced visitor amenities, and better upkeep of public spaces, the site has significant potential to be developed as an attractive recreational and eco-tourism destination. During the monsoon season, excess water from the pond overflows into the Guniya River, contributing to its flow.

Visual observations indicate that the pond exhibits signs of slight eutrophication, primarily due to the organic matter from the surrounding areas. While the water body retains its ecological significance as the river's source, localized nutrient enrichment may adversely affect its water quality and ecological health if left unmanaged.

- a) Localized pollution resulting from indiscriminate disposal of domestic waste and litter around the pond.
- b) Need for periodic maintenance and upkeep of the existing Riverfront Development (RfD) infrastructure, including pathways, landscaping, lighting, and public amenities.

Figure 4: Existing riverfront work at Singhwasa Talab

- a) Undertake regular maintenance of the existing Riverfront Development (RfD) works, including repair of damaged infrastructure, landscaping, cleaning, and improvement of visitor facilities including boating etc.
- b) Strengthen solid waste management through installation of adequate waste bins, regular collection, and enforcement against littering.
- c) Ensure that no untreated wastewater, greywater, or solid waste is discharged into the pond or the originating stretch of the river.

- d) Aerators may be installed to check the organic pollution.
- e) Develop awareness and information signage to educate visitors and local residents on the ecological importance of the river's source and promote responsible behavior.
- f) Implement periodic water quality monitoring to preserve the ecological health and aesthetic value of the water body.

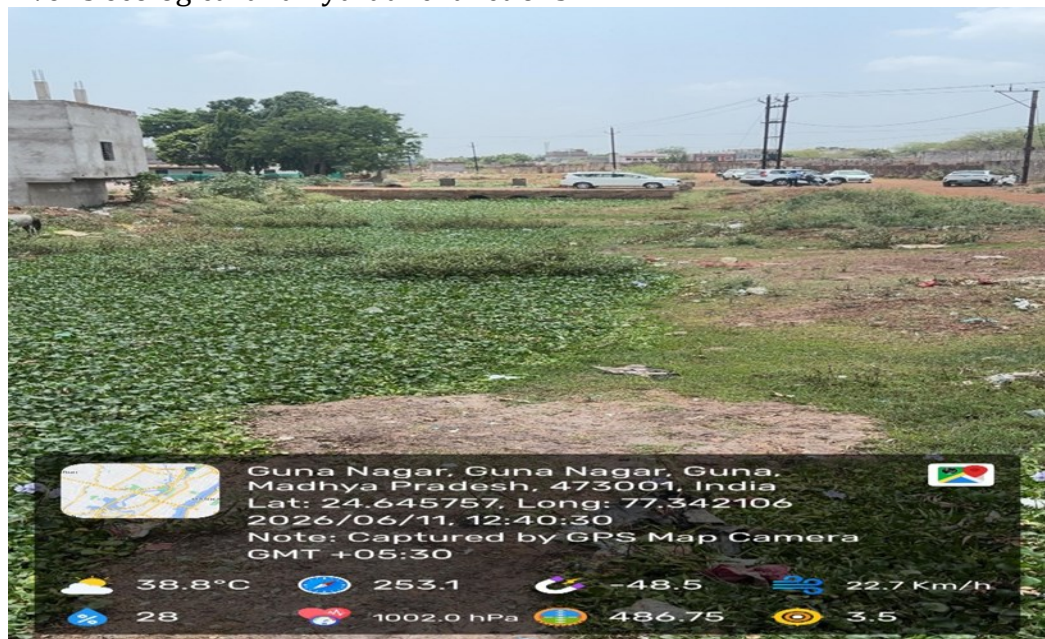
The site was observed to be under significant environmental stress due to the continuous discharge of untreated domestic wastewater into the river, resulting in severe eutrophication. The accumulation of nutrient-rich wastewater has led to excessive growth of aquatic vegetation and algal blooms, adversely affecting the ecological health and aesthetic value of the river stretch. In addition, widespread encroachments were observed along the riverbanks, reducing the effective river

The river stretch exhibits heavy eutrophication, characterized by dense aquatic vegetation, algal growth, and poor water quality resulting from sustained inflow of untreated domestic wastewater. The deteriorated water quality is indicative of a high organic and nutrient load, with potential adverse impacts on dissolved oxygen levels and aquatic biodiversity.

- a) Continuous discharge of untreated domestic wastewater leading to severe eutrophication and degradation of water quality.
- b) Extensive encroachment within the river corridor, restricting the natural channel and impacting the river's ecological and hydraulic functions.
- c) Degradation of the riverfront environment due to unplanned anthropogenic activities and inadequate management of the river buffer zone.

Figure 5: Eutrophication in Guniya River stretch at Bandha

- a) Eliminate Wastewater Discharge: Identify and intercept all untreated domestic wastewater outfalls entering the river and divert them to an appropriate sewage treatment facility or decentralized treatment system. Ensure that no untreated wastewater is discharged directly into the river and establish regular monitoring to prevent future illegal discharges.
- b) Remove Encroachments: Undertake demarcation of the river boundary and remove encroachments within the river corridor in accordance with applicable regulations. Restore the reclaimed riverbanks with native vegetation and a green buffer to prevent re-encroachment and improve the river's ecological and hydraulic functions.

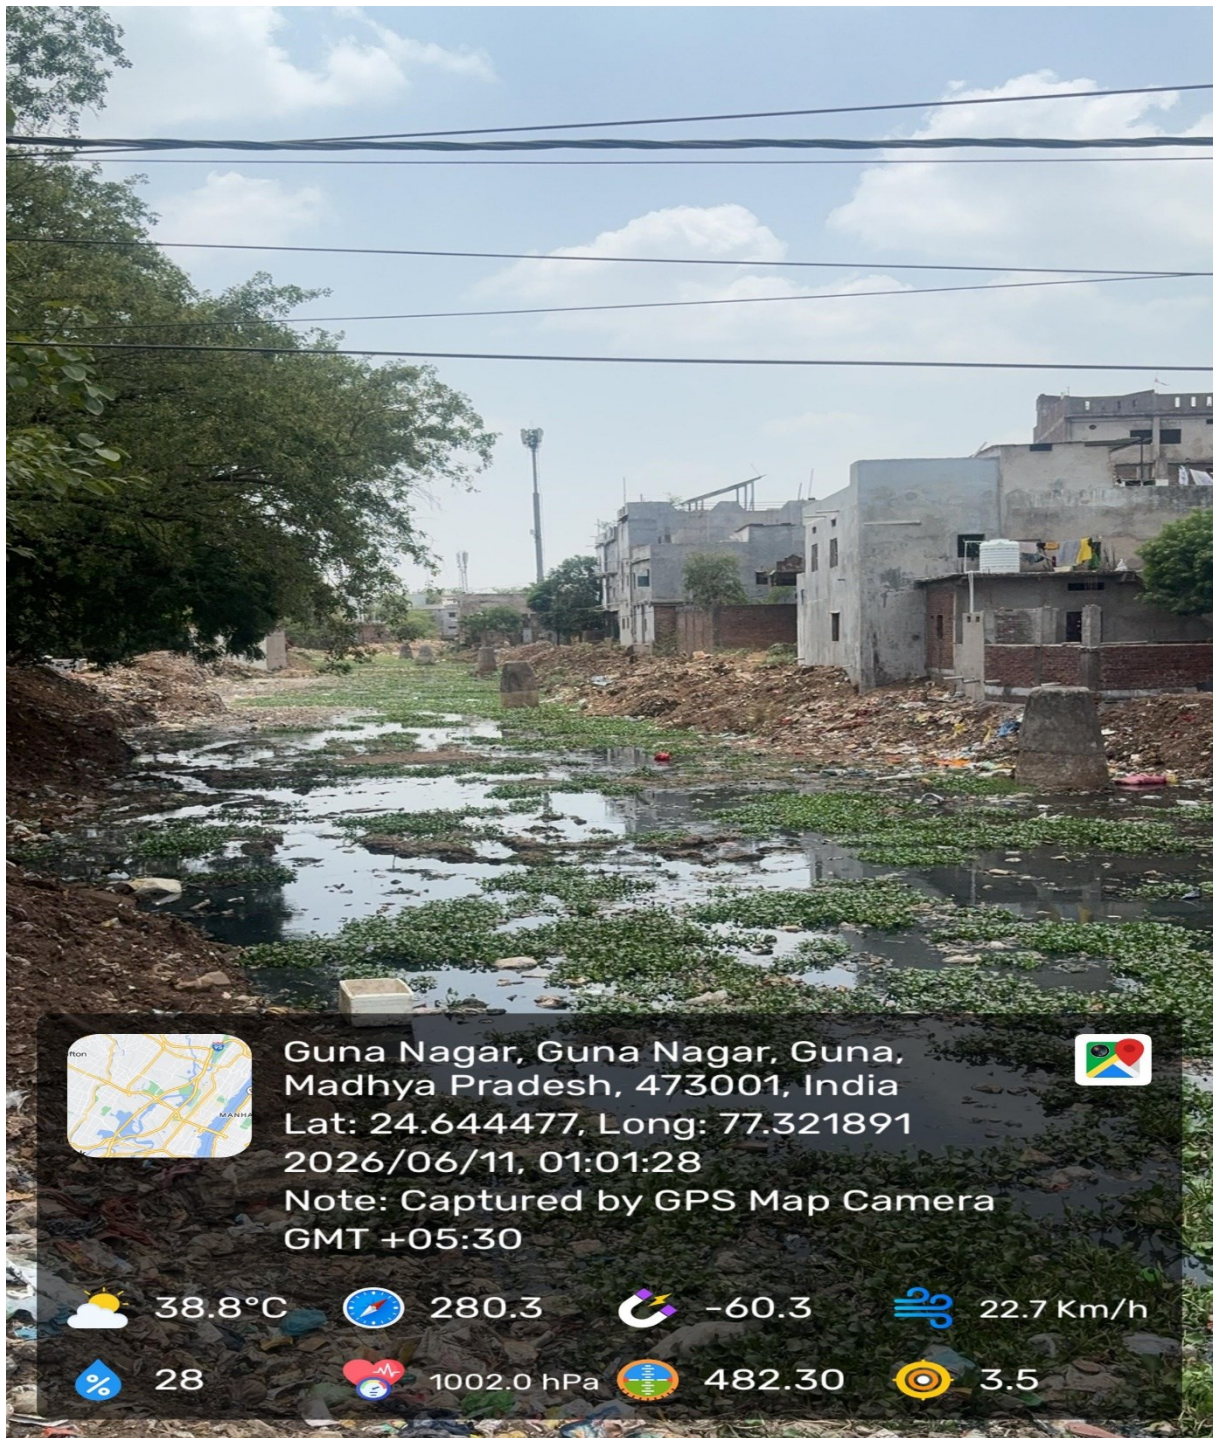
The river stretch was observed to be severely degraded due to indiscriminate dumping of municipal solid waste, and continuous discharge of untreated domestic wastewater. Additionally, the presence of a sewer line was observed running through the riverbed. These activities have significantly impaired the river's ecological health, resulting in excessive aquatic weed and algal growth. The accumulation of waste and encroachment of utility infrastructure within the river channel have also reduced its hydraulic efficiency and adversely affected its aesthetic value.

The river exhibits heavy eutrophication, characterized by dense growth of aquatic vegetation, stagnant water, and high organic loading caused by untreated wastewater inflows. The water quality is poor and indicates substantial nutrient enrichment, making the stretch environmentally stressed.

- a) Continuous discharge of untreated domestic wastewater leading to severe eutrophication and deterioration of water quality.
- b) Indiscriminate dumping of municipal solid waste within and along the river channel.
- c) Sewer line passing through the riverbed, posing risks of leakage, obstruction to natural flow, and limiting future river restoration efforts.

Figure 6: Eutrophication and solid waste disposal at Kalapatha Road stretch

- a) Treat all wastewater outfalls to eliminate direct discharge into the river.
- b) Remove accumulated solid waste from the river channel and establish an efficient solid waste management system, including waste collection infrastructure and regular cleaning.
- c) Assess the structural condition of the sewer line and, wherever feasible, relocate it outside the river corridor or provide adequate protection to prevent leakage and minimize its impact on the river ecosystem.
- d) Restore the affected river stretch through cleaning, removal of aquatic weeds, development of a green riparian buffer, and regular water quality monitoring to improve ecological health and prevent future degradation.

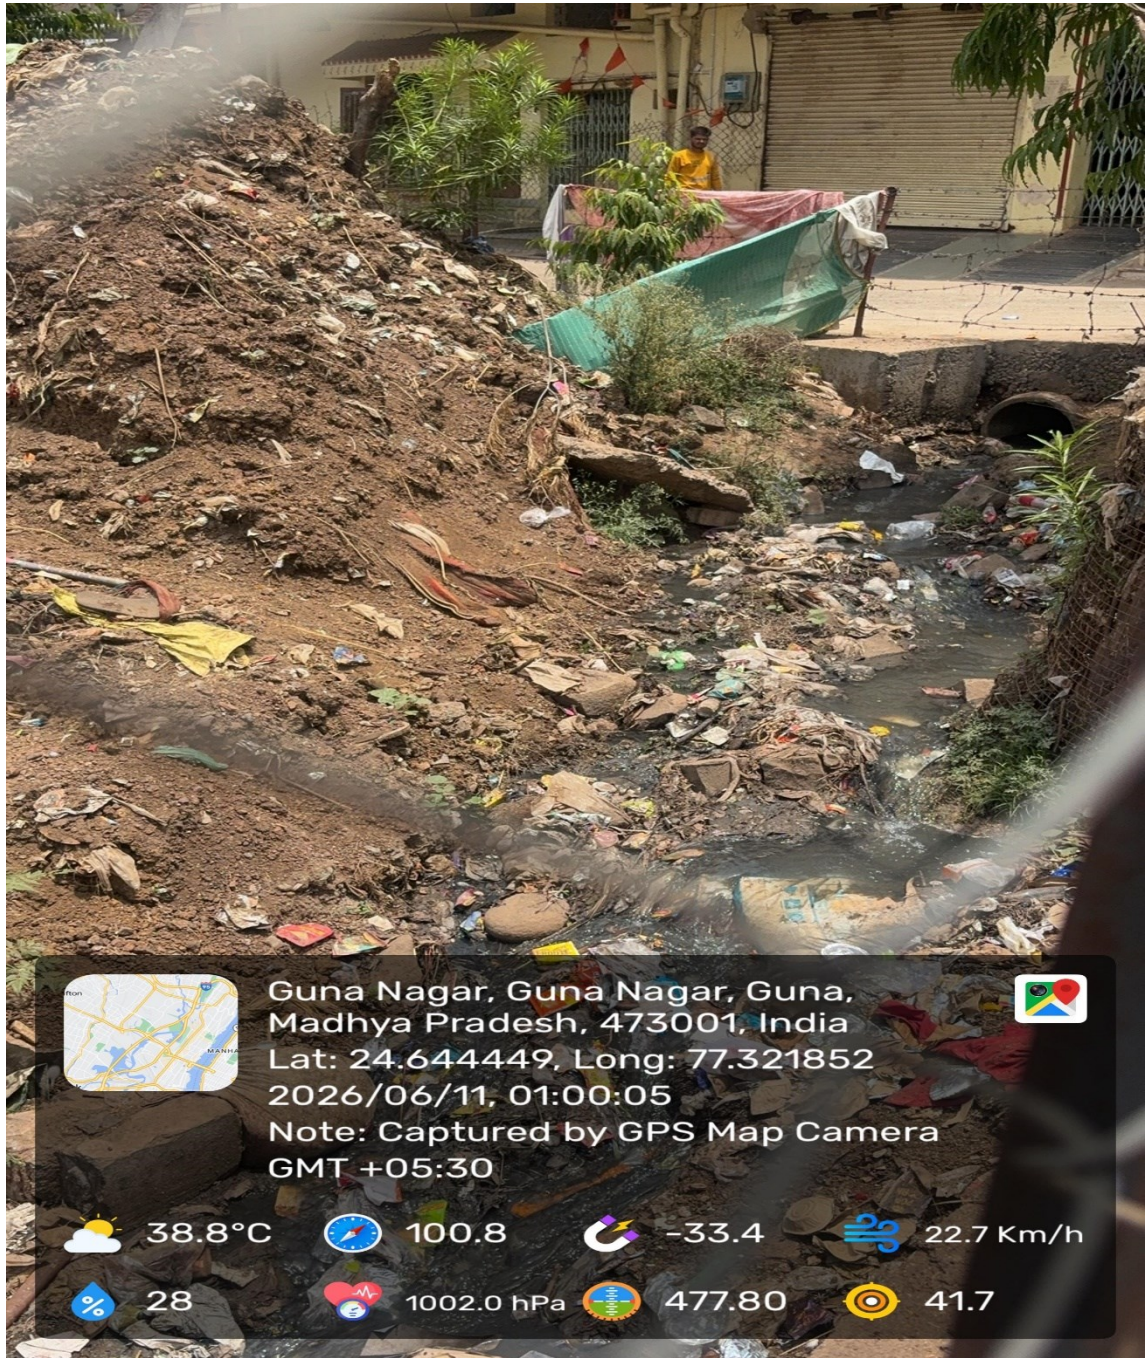
The river stretch was observed to be affected by indiscriminate dumping of municipal solid waste along the riverbanks and within the channel, resulting in deterioration of the river environment and obstruction of natural flow. A sewer line was found passing through the riverbed, posing a potential risk of leakage, structural damage, and interference with future river restoration activities. In addition, the excavated silt and mud from recent desilting operations had been deposited along the riverbanks instead of being scientifically disposed of, creating the risk of re-entry into the river during rainfall and increasing bank instability.

The water quality was observed to be degraded due to the accumulation of solid waste and localized organic pollution. The continued waste dumping and the presence of sewer infrastructure within the river corridor pose a significant risk to future water quality deterioration.

- a) Indiscriminate dumping of municipal solid waste along the riverbanks and within the river channel.
- b) Sewer line running through the riverbed, posing risks of leakage, maintenance challenges, and obstruction to river restoration.
- c) Excavated mud and silt deposited on the riverbanks after desilting, with the potential to be washed back into the river during monsoon, causing secondary siltation.

Figure 7: Discharge of wastewater at Banskhedi stretch

- a) Remove all accumulated solid waste from the river corridor and strengthen solid waste management through regular collection, installation of waste bins, and enforcement against illegal dumping.
- b) Assess the condition of the sewer line and, wherever feasible, relocate it outside the river corridor or provide adequate structural protection to eliminate the risk of leakage and facilitate future river restoration works.
- c) Dispose of desilted material at designated disposal sites or utilize it for suitable beneficial purposes after quality assessment, ensuring that excavated mud is not stored along the riverbanks where it can be washed back into the river during rainfall.

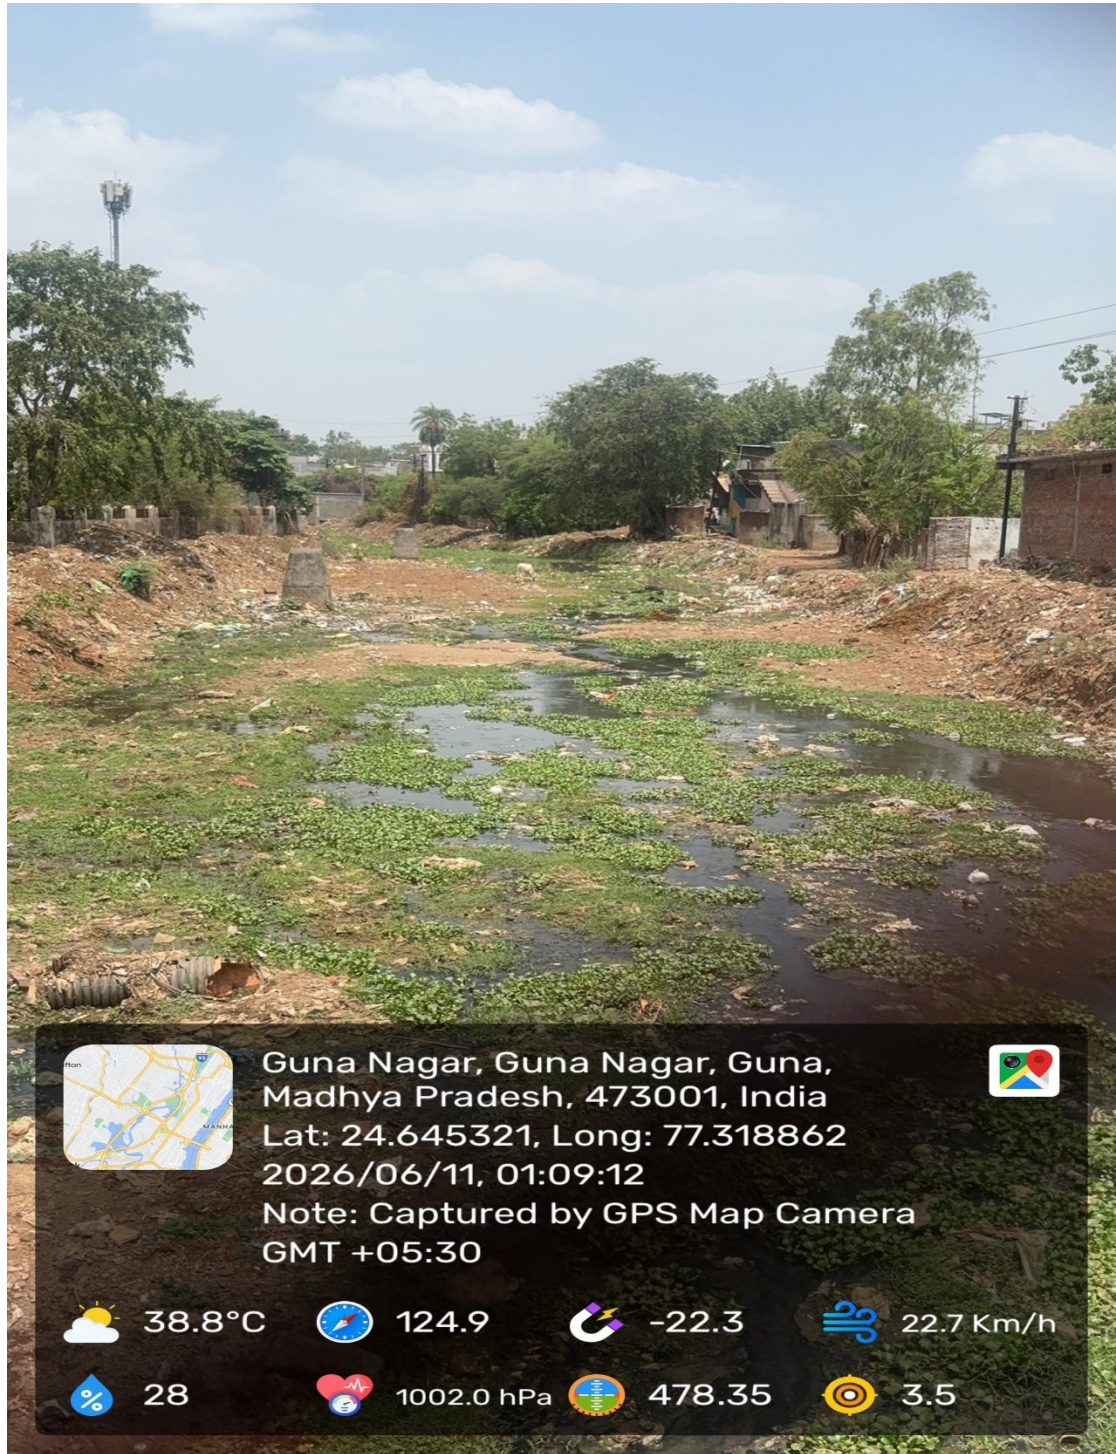
The river stretch was observed to be impacted by indiscriminate dumping of municipal solid waste and localized eutrophication resulting from nutrient enrichment. A 3.5 MLD Sewage Treatment Plant (STP) is operational in the area, of which approximately 1 MLD of treated wastewater is being reused, while the remaining treated effluent is discharged into the river.

The river exhibits signs of eutrophication, characterized by localized growth of aquatic weeds and algal proliferation. The treated effluent from the STP appears to reduce the direct impact of untreated sewage; however, persistent solid waste accumulation continue to impair water quality and ecological health.

- a) Indiscriminate dumping of municipal solid waste along the riverbanks and within the river channel.
- b) Localized eutrophication caused by nutrient enrichment from wastewater and surface runoff.

Figure 8: Solid waste and eutrophication at Bada Pul stretch

- a) Strengthen solid waste management through regular collection, installation of waste bins, and strict enforcement to eliminate dumping within the river corridor.
- b) Implement measures to reduce nutrient loading by preventing untreated wastewater inflows, controlling non-point source pollution, and periodically removing excessive aquatic weeds where necessary.
- c) Maximize the reuse of treated wastewater for applications such as irrigation, industrial use, landscaping, urban forestry, and lake rejuvenation, thereby minimizing treated effluent discharge into the river. Continuous monitoring of STP performance and treated effluent quality should be undertaken to ensure compliance with prescribed discharge standards.

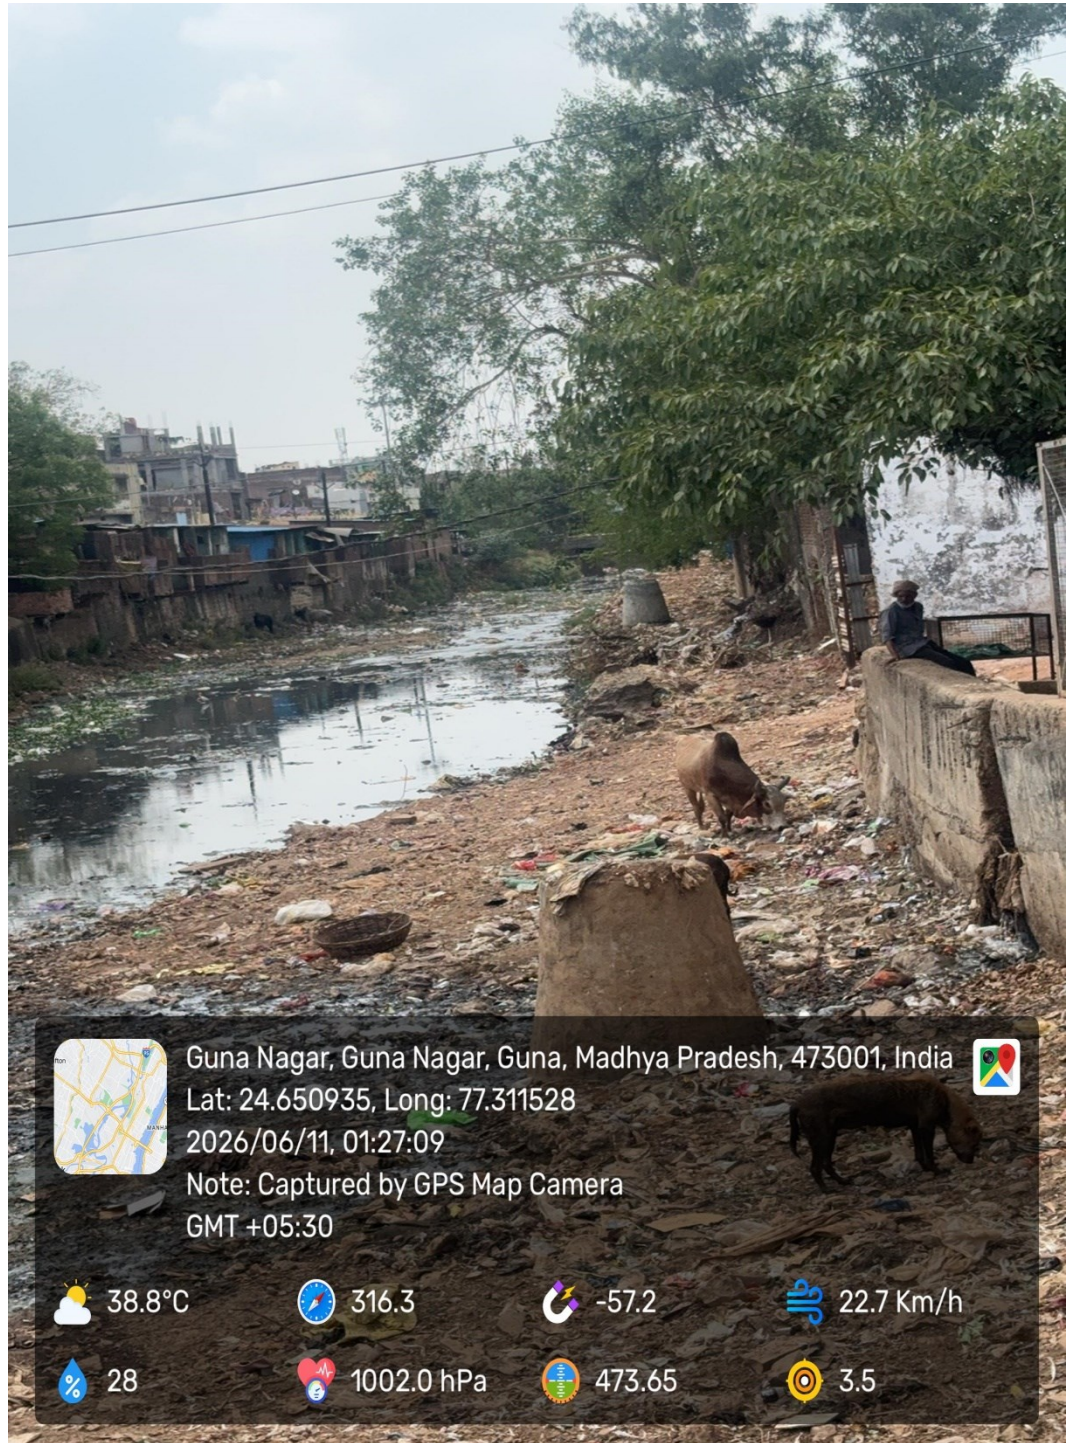
The river stretch was observed to be in a highly degraded condition due to indiscriminate dumping of municipal solid waste, extremely poor water quality, and the presence of a slaughterhouse in close proximity to the river. A strong foul odor was evident throughout the stretch, indicating a high organic pollution load and possible discharge of untreated wastewater and slaughterhouse waste into the river. The combined impact of these activities has severely degraded the river's ecological condition, visual appeal, and public health environment.

The water quality was observed to be very poor, with dark-colored, stagnant water accompanied by a persistent foul odor. Visual evidence suggests a high organic and nutrient load, low dissolved oxygen levels, and significant pollution, rendering the stretch environmentally stressed and unsuitable for sustaining a healthy aquatic ecosystem.

- a) Indiscriminate dumping of municipal solid waste along the riverbanks and within the river channel.
- b) Very poor water quality characterized by high organic pollution, stagnant conditions, and persistent foul odor.
- c) Presence of slaughterhouses in the vicinity, posing a risk of untreated or inadequately treated effluent, blood, and organic waste entering the river.
- d) Unsanitary riverfront conditions, adversely affecting public health, aesthetics, and the ecological integrity of the river.

Figure 9: Pollution at Haat Road stretch

- a) Immediate removal of accumulated solid waste from the river corridor and strengthen solid waste management through regular collection, surveillance, and strict enforcement against illegal dumping.
- b) Conduct a detailed inspection of the slaughterhouse to ensure that no untreated effluent or solid waste is discharged into the river. Adequate effluent treatment facilities should be installed or upgraded, and compliance should be monitored regularly.
- c) Identify and eliminate all sources of untreated wastewater entering the river, followed by restoration of the affected stretch through cleaning, wherever required, and removal of accumulated organic matter.
- d) Implement regular water quality monitoring, odor control measures, and development of a vegetated riparian buffer to improve the ecological health, environmental quality, and public amenity value of the river corridor.

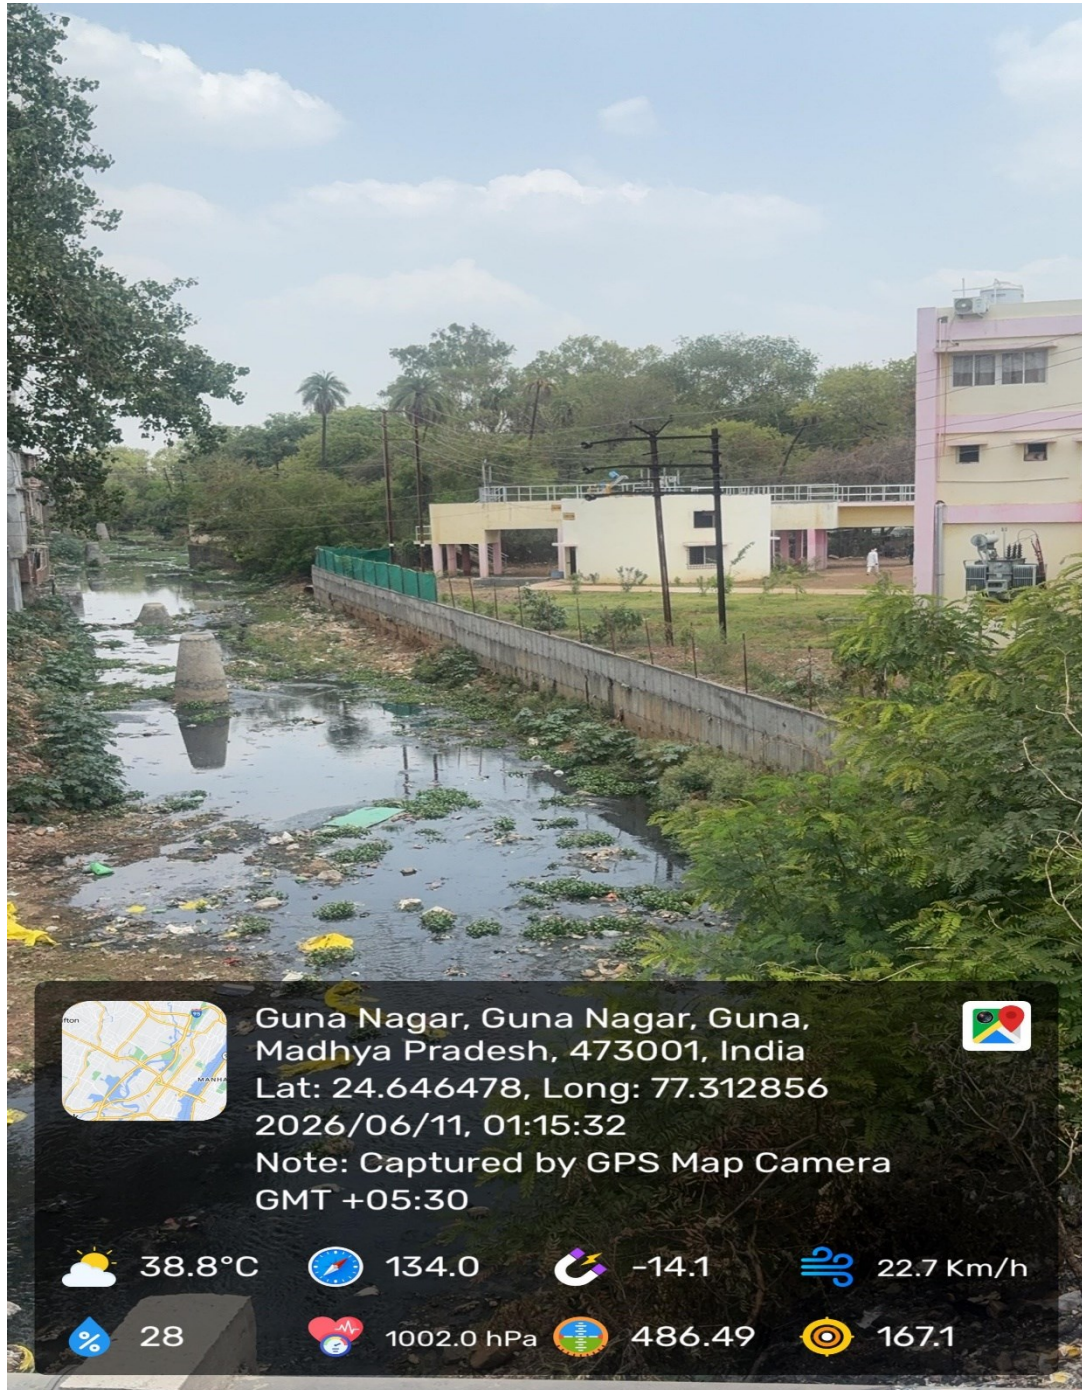
The river stretch was observed to be severely degraded due to dumping of both solid and liquid waste, resulting in significant deterioration of its ecological and aesthetic condition. The water appeared highly polluted, with visible waste accumulation, discoloration, and poor flow conditions. During stakeholder interactions, local residents reported that the river once had clear water and served as an important community resource, highlighting the extent of degradation that has occurred over time due to unplanned urbanization, inadequate waste management, and continuous pollution.

The water quality was observed to be very poor, characterized by high turbidity, dark-colored water, visible floating waste, and indications of substantial organic pollution. The continuous inflow of liquid waste has adversely affected the river's self-purification capacity, resulting in an environmentally stressed river stretch with limited ecological value.

- a) Dumping of solid waste along the riverbanks and within the river channel.
- b) Continuous discharge of liquid waste, leading to severe deterioration of water quality and degradation of the river ecosystem.
- c) Loss of the river's natural ecological character and decline in its aesthetic and recreational value, as reflected by local accounts of the river previously having clear and clean water.
- d) Inadequate waste management practices and lack of effective pollution control measures within the river corridor.

Figure 10: Solid and liquid waste pollution at Shitala Ghat stretch

- a) Eliminate all sources of solid and liquid waste entering the river through interception of wastewater drains, strengthening of sewerage infrastructure, and implementation of an effective solid waste management system.
- b) Undertake intensive cleaning of the river channel and riverbanks, followed by ecological restoration measures such as riparian plantation, bioengineering, and habitat improvement to restore the river's natural character.
- c) Establish a regular water quality monitoring program and enforce strict measures against illegal waste disposal to prevent further degradation.
- d) Promote community participation through awareness campaigns, citizen-led monitoring, and river stewardship initiatives to revive the river and restore its historical ecological and cultural significance.

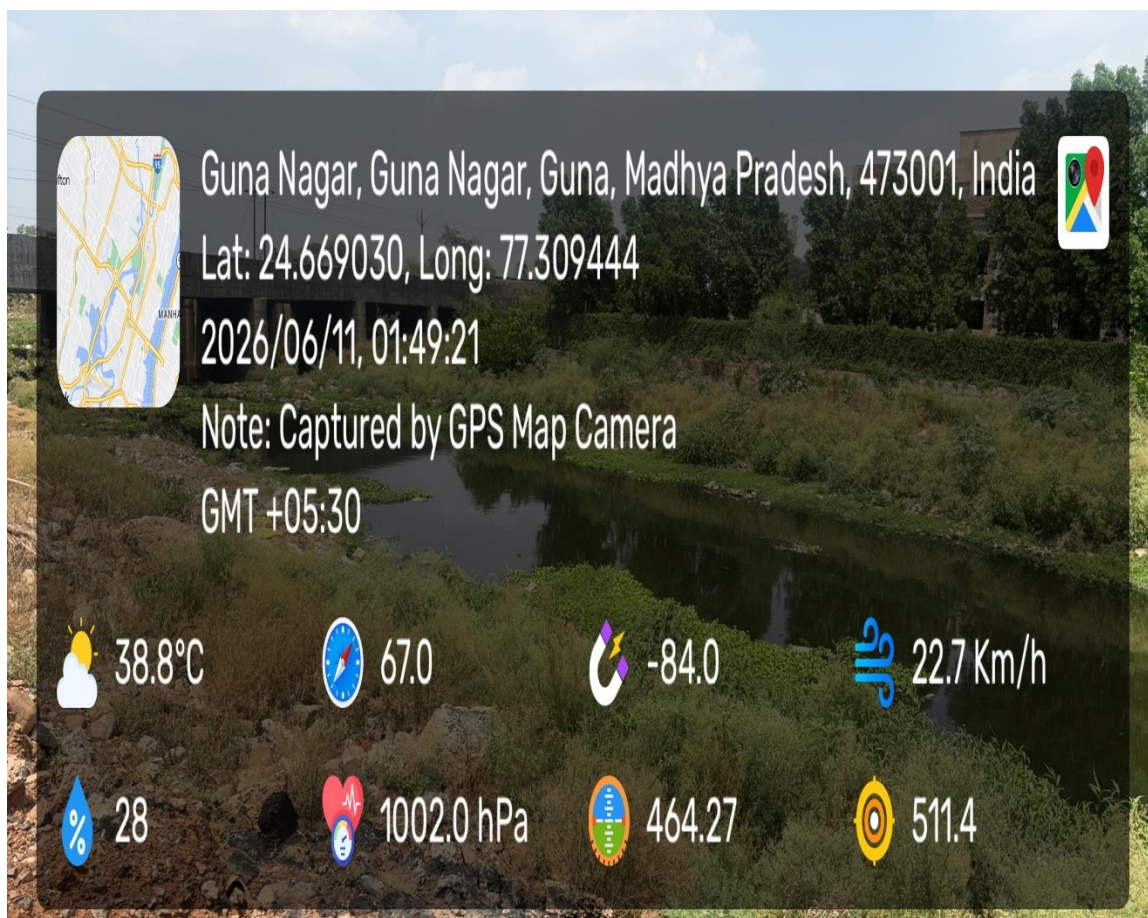
The river stretch passes through a predominantly rural (gramin) landscape with relatively limited urban and industrial influence. The river exhibited better flow conditions compared to upstream urban stretches, contributing to improved dilution and self-purification capacity. The surrounding area is characterized by agricultural land and scattered rural settlements, and the river retains much of its natural channel morphology and ecological character.

The water quality was observed to be comparatively good, with better flow conditions, lower levels of visible pollution, and minimal accumulation of solid waste. The improved hydraulic conditions enhance the river's natural assimilative capacity, resulting in better overall ecological health than the urban stretches.

- a) Potential risk of future pollution from expanding rural settlements and agricultural runoff.
- b) Localized disposal of domestic waste and agricultural residues at a few locations.
- c) Need to preserve the existing natural river corridor and prevent encroachment or unplanned development.

Figure 11: Water quality at Sakatpur stretch

- a) Protect the river stretch by preventing discharge of untreated wastewater and restricting solid waste dumping to maintain the existing water quality.
- b) Establish regular water quality monitoring and promote sustainable agricultural practices to minimize nutrient and pesticide runoff into the river.
- c) Conserve the natural riparian vegetation through plantation and riverbank protection measures, while engaging local communities in river conservation and awareness programs to ensure the long-term ecological health of the river.
