**Site Visit Report**  
**for**  
**Katha River/ Drain in Saharanpur and**  
**Shamli, Uttar Pradesh**

**Date of visit– 20.01.2026 to 22.01.2026**

# Executive Summary

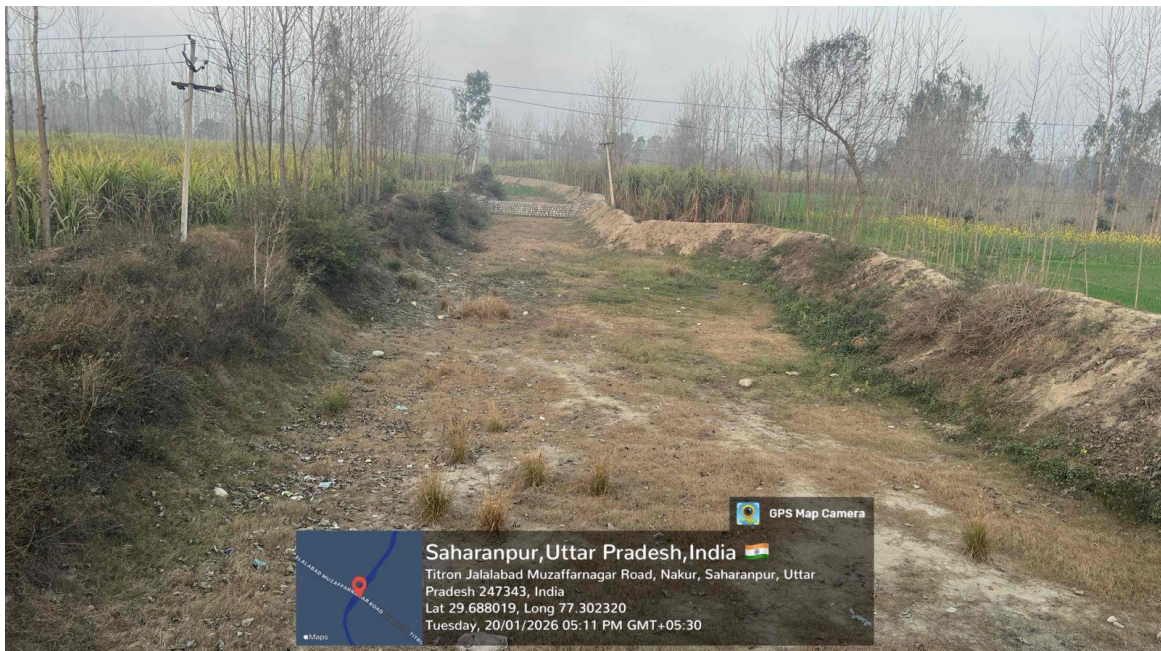
- i). **Waste Accumulation:** Scattered plastic and solid waste on streambed
- ii). **Water Level:** Completely dried-up

Location 2: Titron Jalalabad Muzaffarnagar Road, Nakur, Saharanpur (Downstream)

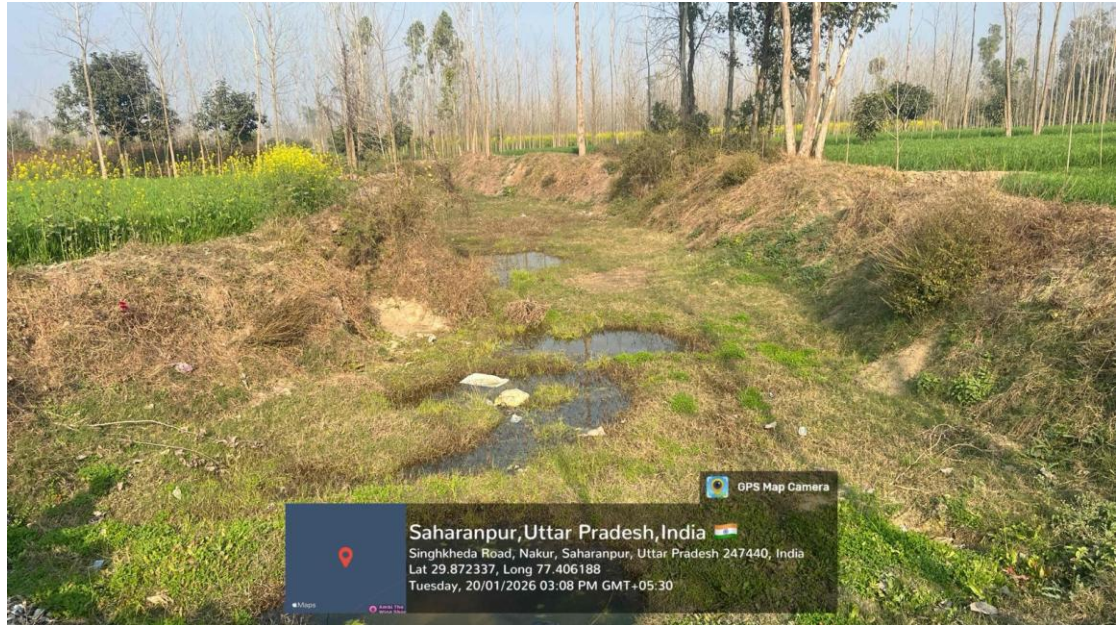
### Location 4: Drain Section with Bank Stabilization

- i). **Bank Conditions:** Partially stabilized banks with stone/brick reinforcement at certain points
- ii). **Vegetation:** Dense riparian vegetation (willows, poplars) planted along banks
- iii). **Access:** Walking paths visible along drain banks
- iv). **Water Presence:** Stagnant water with algal bloom; minimal flow velocity

- v). **Encroachment Form:** Effective use of drain as dumping ground and access path rather than formal encroachment structures

Location 4: Drain Section with Bank Stabilization & stagnant nearby domestic waste

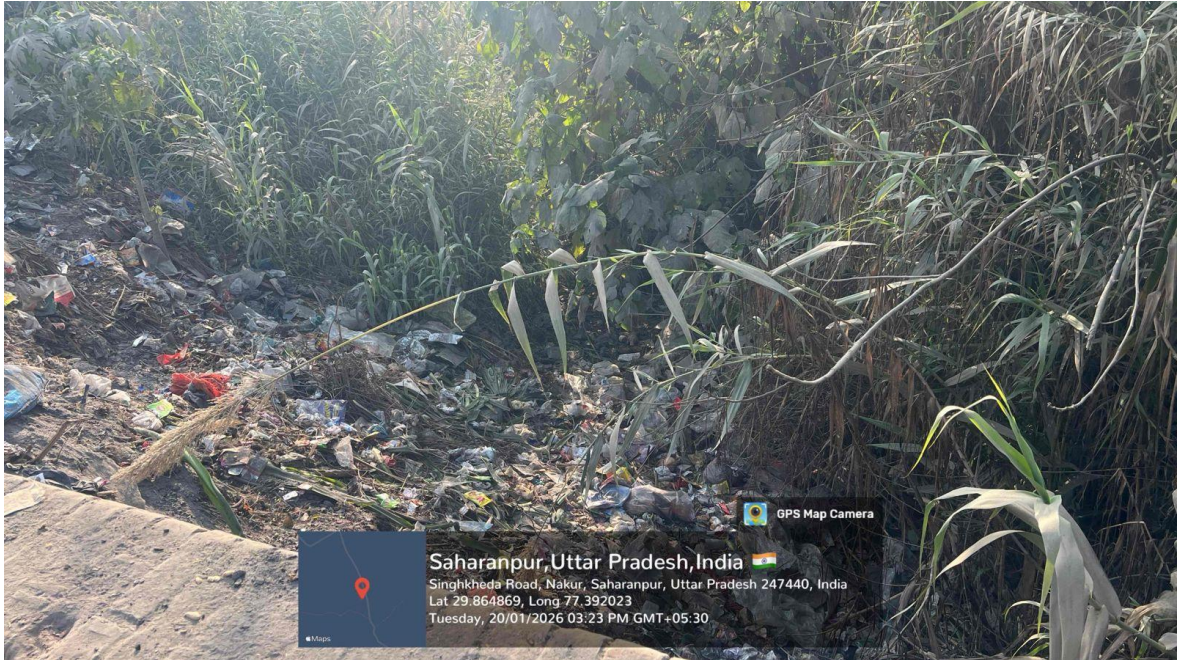
## **Location 6: Drain Section with Visible Pollution – Singhkheda Road**

- i). **Pollution Type:** Untreated sewage evident; dark discolored water with organic debris
- ii). **Riparian Vegetation:** Sparse due to pollution stress
- iii). **Animal Activity:** Birds and aquatic fauna absent (indicating ecological dead zone)
- iv). **Smell/Odor:** Strong odor of decomposition and sewage
- v). **Status:** Active pollution zone requiring immediate remediation

Location 6: Drain Section with Visible Pollution – Singhkheda Road

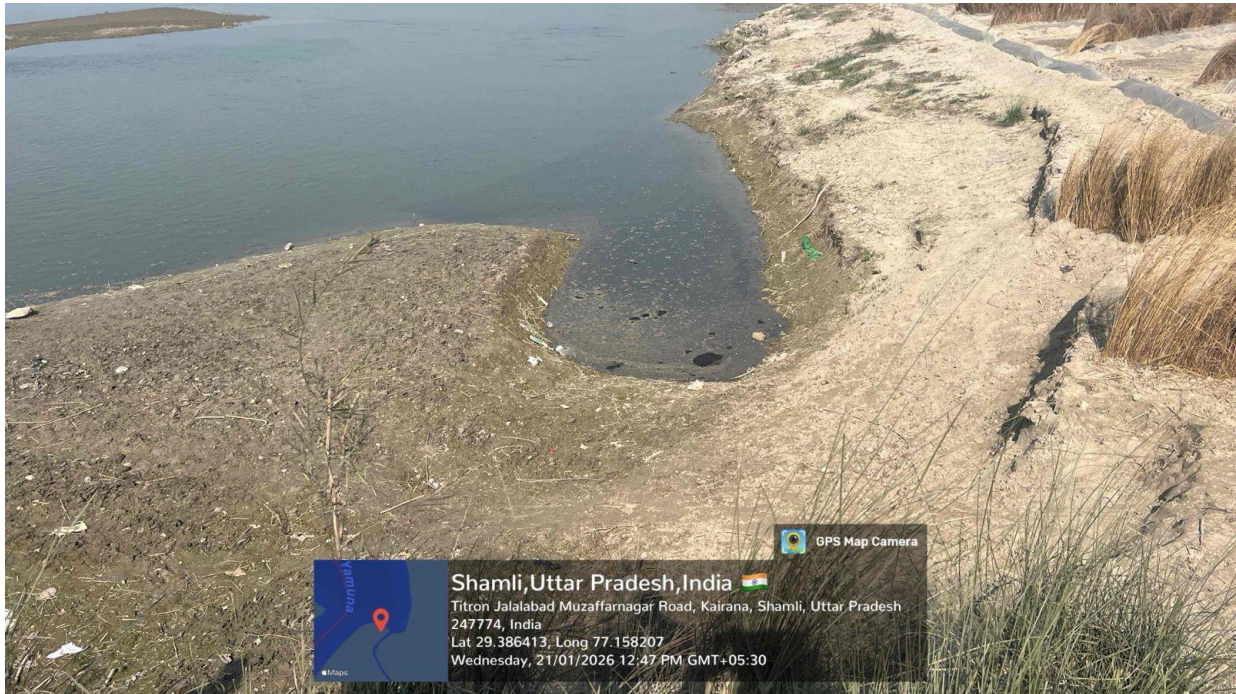
### **Location 1: Merging point of Katha with Yamuna**

- i). **Water Level:** No water
- ii). **Channel:** No proper channel evident
- iii). **Encroachment Status:** No formal encroachment in plantation area

Location 1: Merging point of Katha with Yamuna

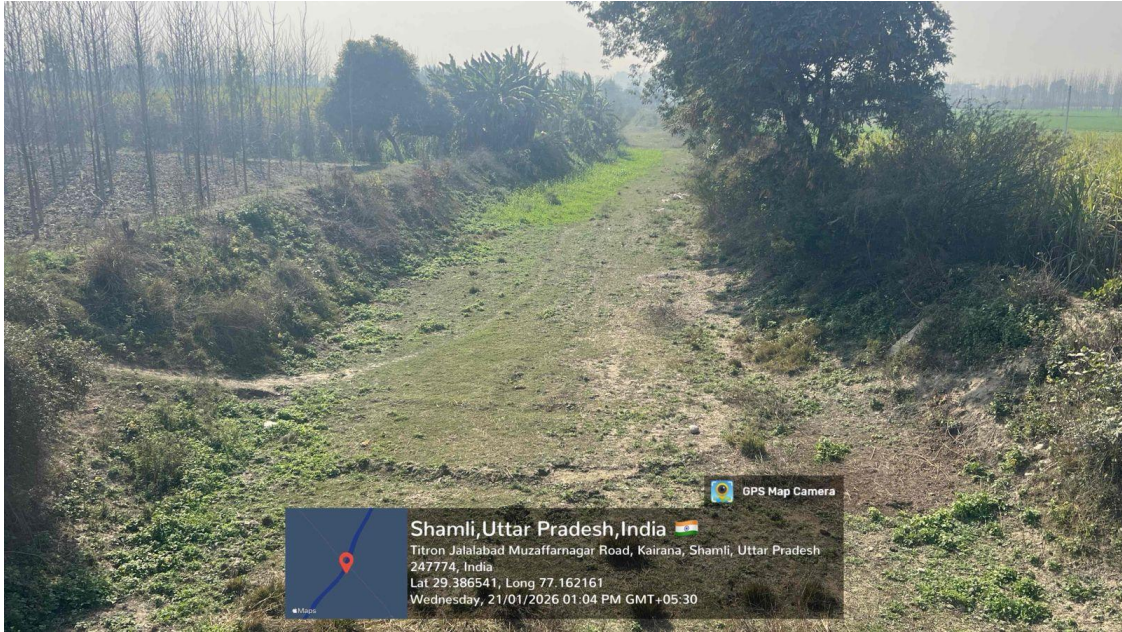
### **Location 2: Dry channel at Titron, Jalalabad**

- i). **Waste Accumulation:** Scattered plastic and solid waste on streambed
- ii). **Water Level:** Completely dried-up

Location 2: Dry channel at Titron, Jalalabad
