# **National Mission for Clean Ganga**

**Site Visit Report for Pollution and  
Encroachment in Manorama/Manwar River,  
Basti, Uttar Pradesh**

**Date – 24.02.2026 to 25.02.2026**

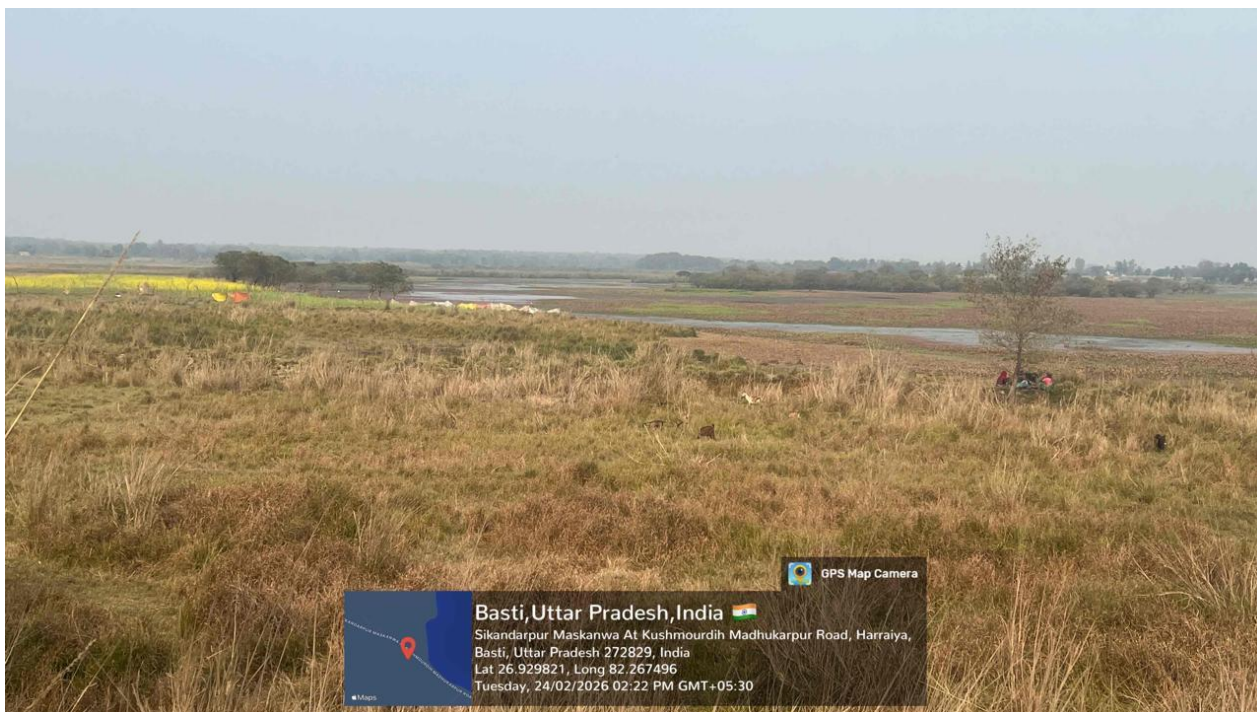
*Figure 2: Manwar River starting point in District Basti, UP (District boundary of Gonda & Basti)*

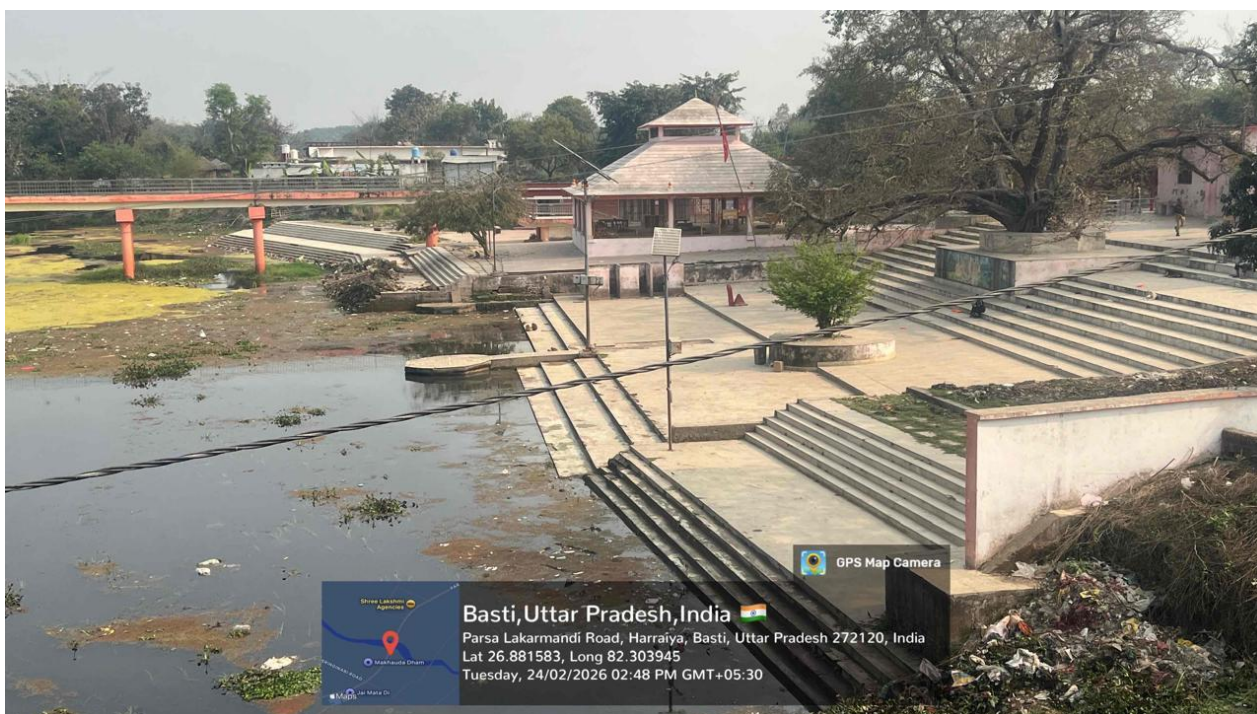
merges with the river during monsoon season. The river was found to be highly polluted due to solid waste dumping and agricultural run-off from adjacent fields into the river causing reduced flow, stagnation, and eutrophic conditions. The list of canal escape drains, as obtained by Irrigation Department, Basti were observed to be non-polluting and not discharging sewage or effluents into the river. Harraiya administration manages sewage collection in dedicated ponds, preventing direct river discharge; major town on the bank is Harraiya.

*Figure 3: Solid waste dumping at Makhaura Dham, Harraiya, Basti, UP*

Immediate priority is solid waste management, community awareness, and data submission from district authorities to enable NMCG's Small Rivers Rejuvenation interventions, including NbS measures, ensuring ecological restoration and sustained flow.

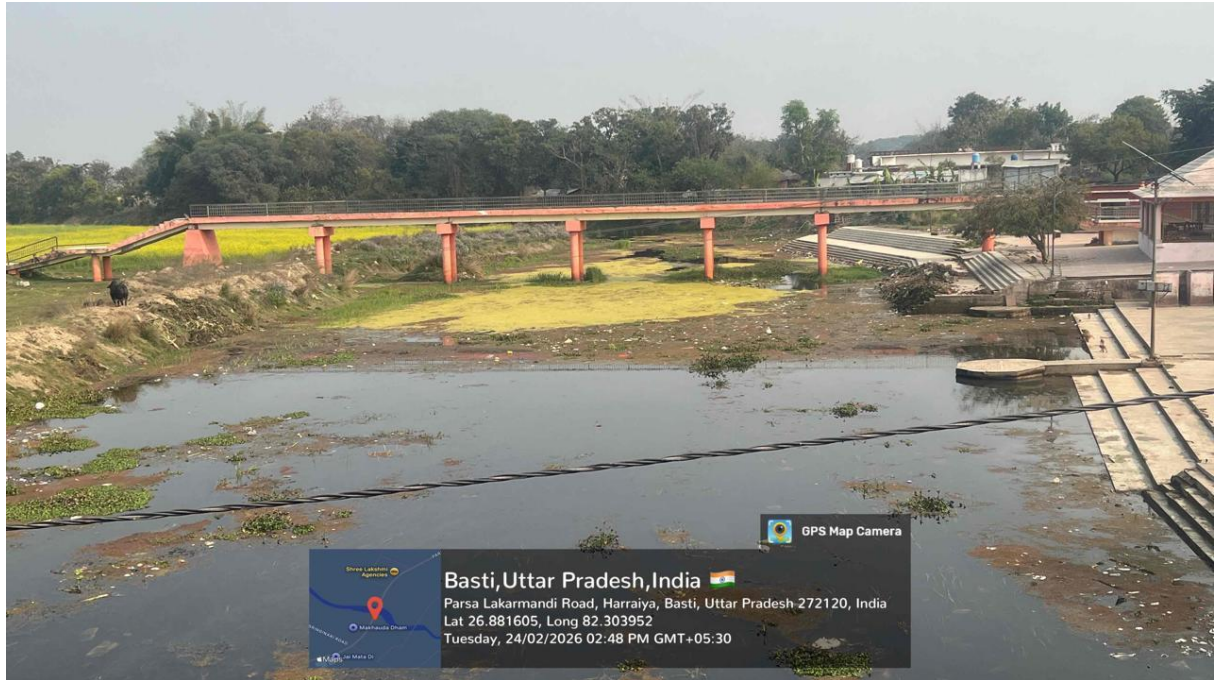
| <b>Location</b> | <b>pH</b> | <b>DO (mg/L)</b> | <b>BOD (mg/L)</b> | <b>COD (mg/L)</b> |
|---|---|---|---|---|
| Makhaura Dham | 7.25 | 4.06 | 6.8 | 36.0 |

Water quality shows organic loading with BOD exceeding bathing class limits at Harraiya, consistent with stagnation from waste blockages.

*Figure 4: Stagnant water at Makhaura Dham, Harraiya, Basti, UP*

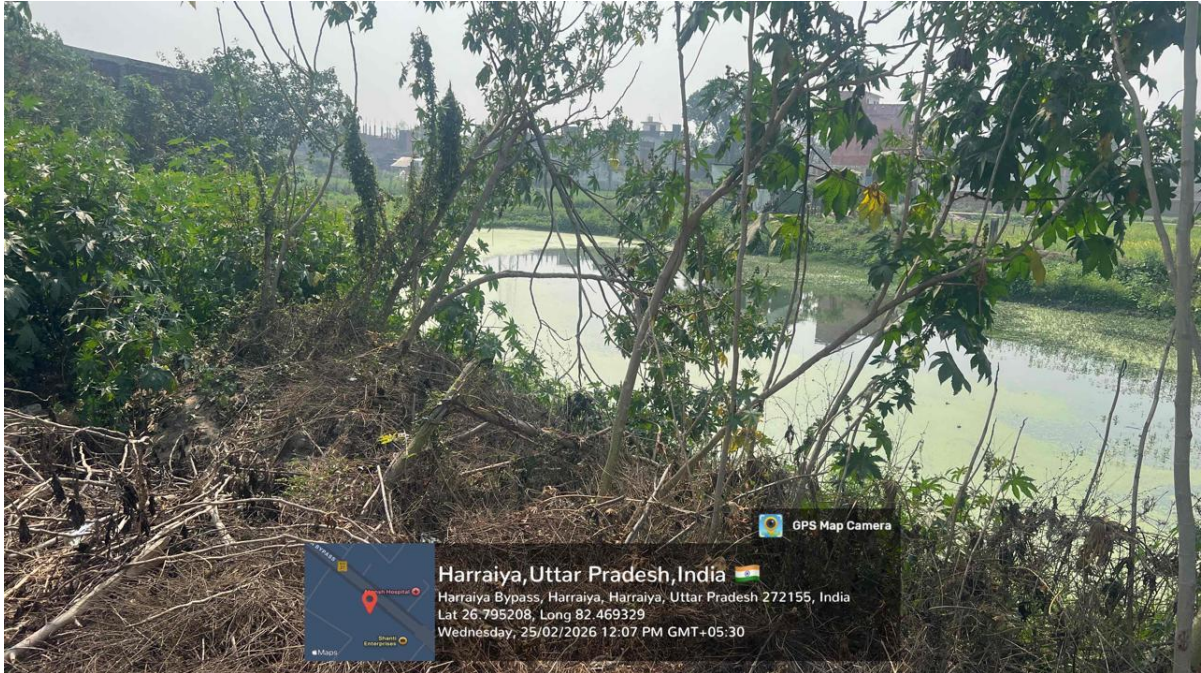
*Figure 10: Another Sewage collection pond at Harraiya, UP*

| <b>Department/Agency</b> | <b>Responsibility</b> | <b>Action Items</b> | <b>Timeline</b> |
|---|---|---|---|
| NMCG | River quality improvement & rejuvenation | NbS for liquid waste management, river bank stabilization through riparian buffers, e-flow augmentation. | 12 months |
